Appendix F – Coastal Shoreline Condition

Draft Supplemental Environmental Assessment
Morgan Shoal Revetment Reconstruction (45th - 51st Street)

Coastal Shoreline Condition Morgan Shoal 2025

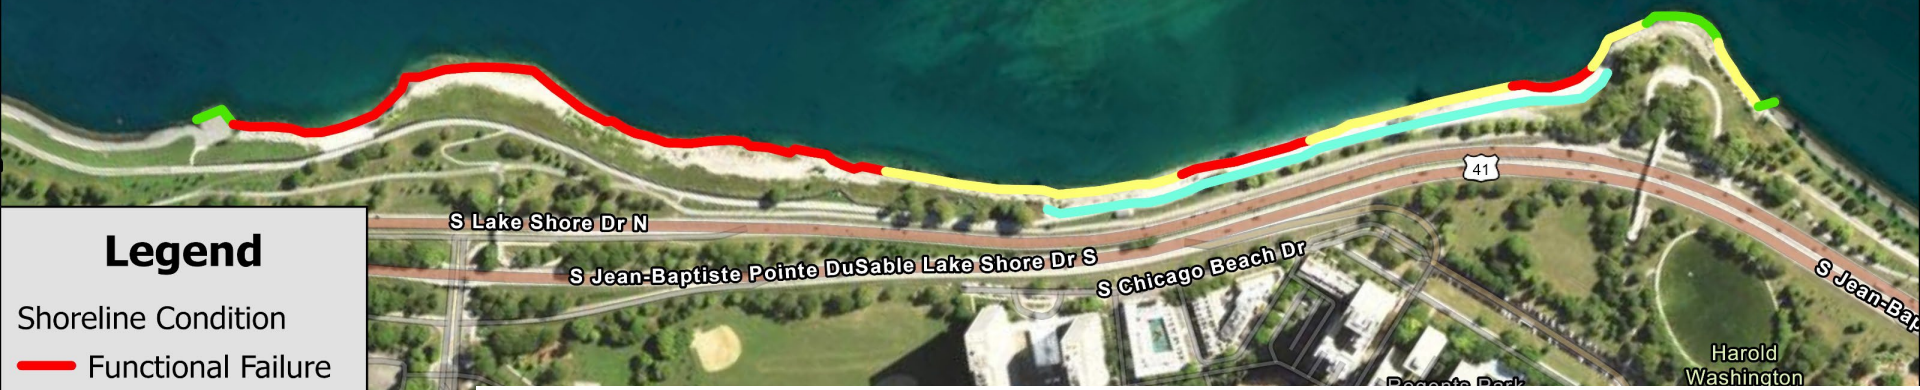
Intact: 424 Linear Feet (LF) (9% of Project area)

Temporarily Intact*: 1674 LF (34% of Project area)

Structural Failure: 1888 LF (38% of Project area)

Functional Failure: 2642 LF (53% of Project area)

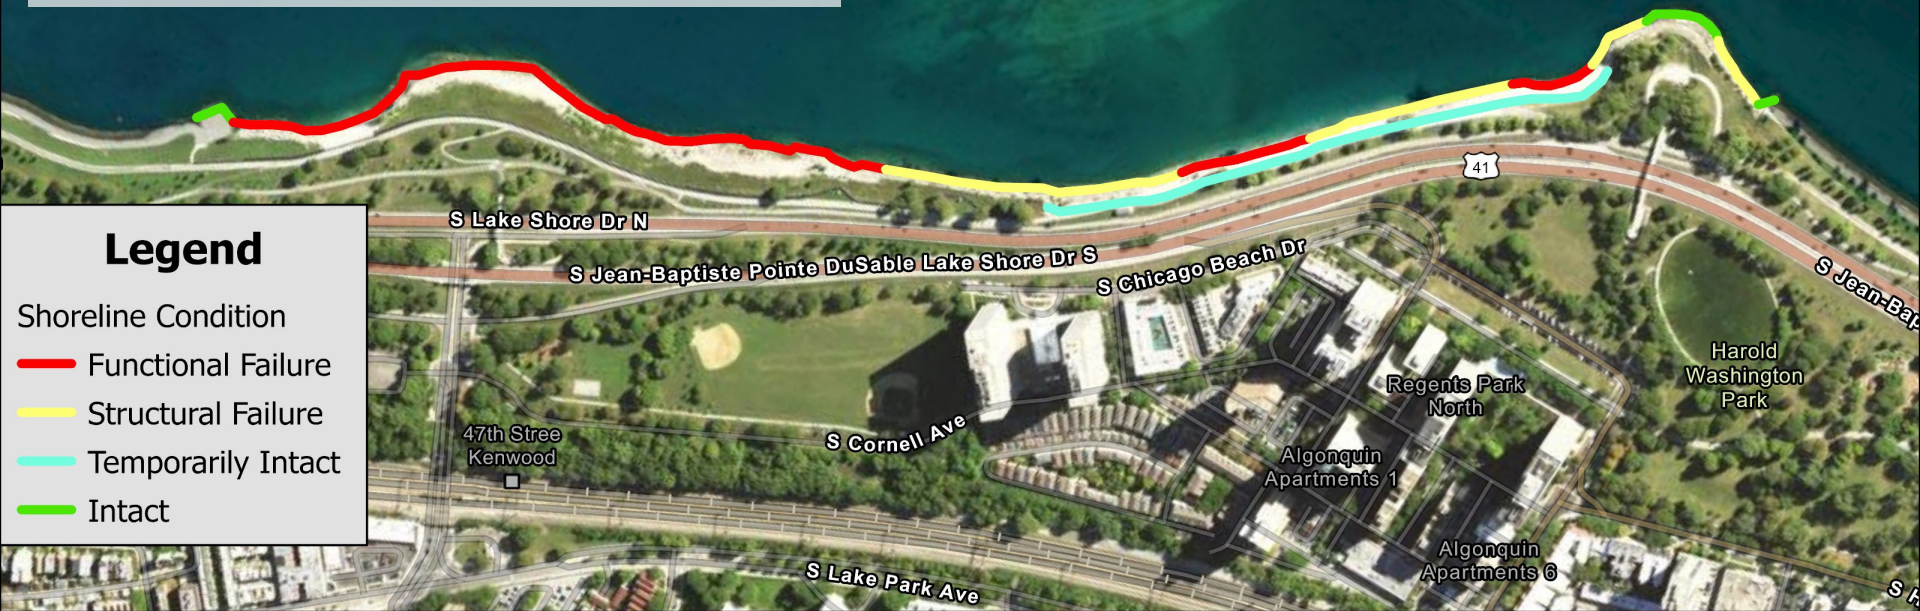
Functional Failure
1920's Limestone

Intact
2012 Limestone

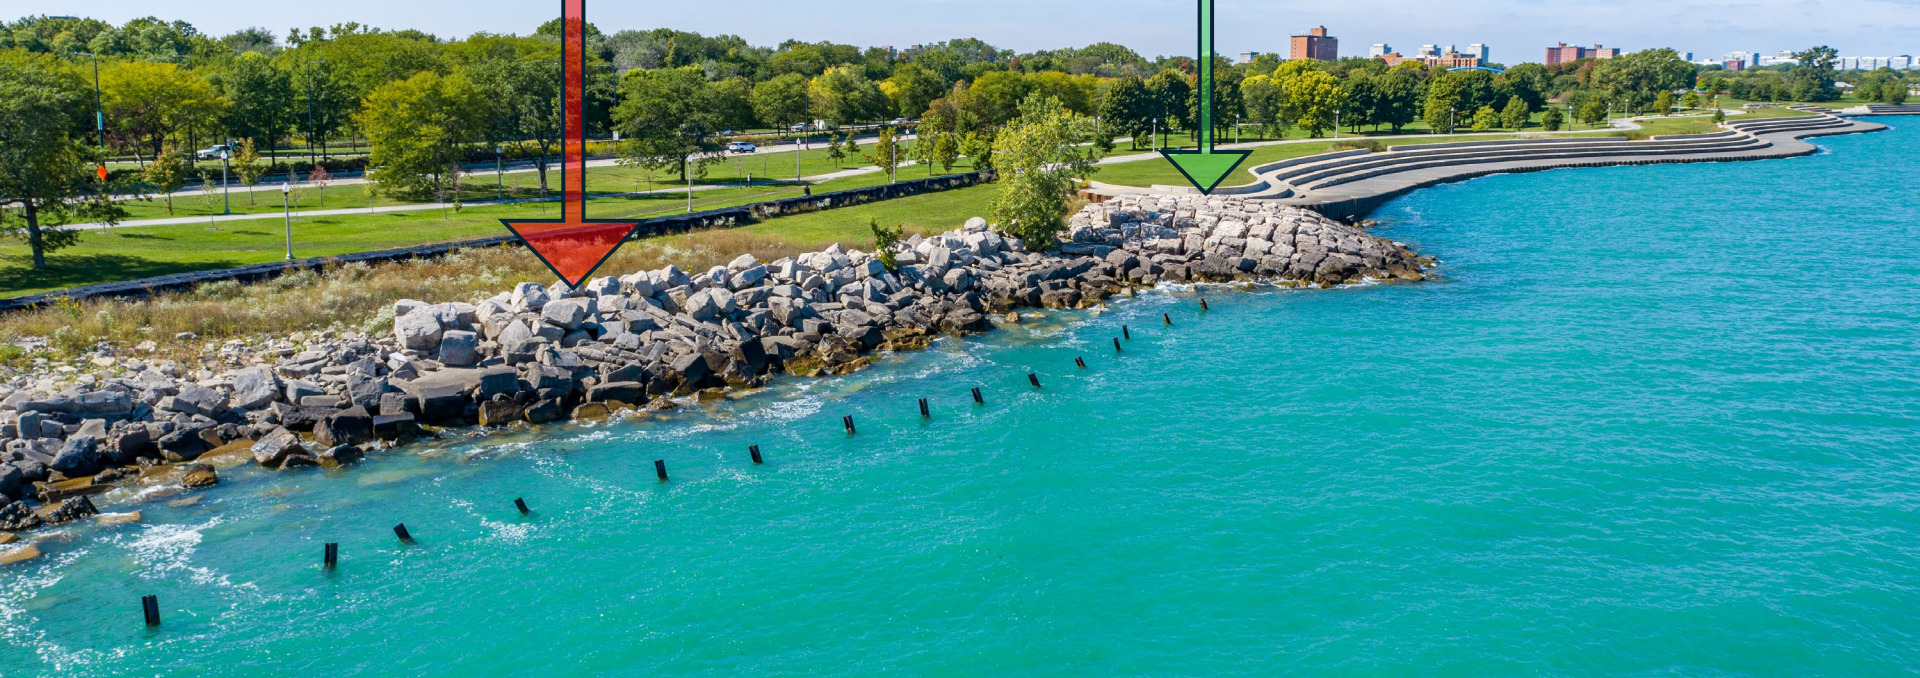
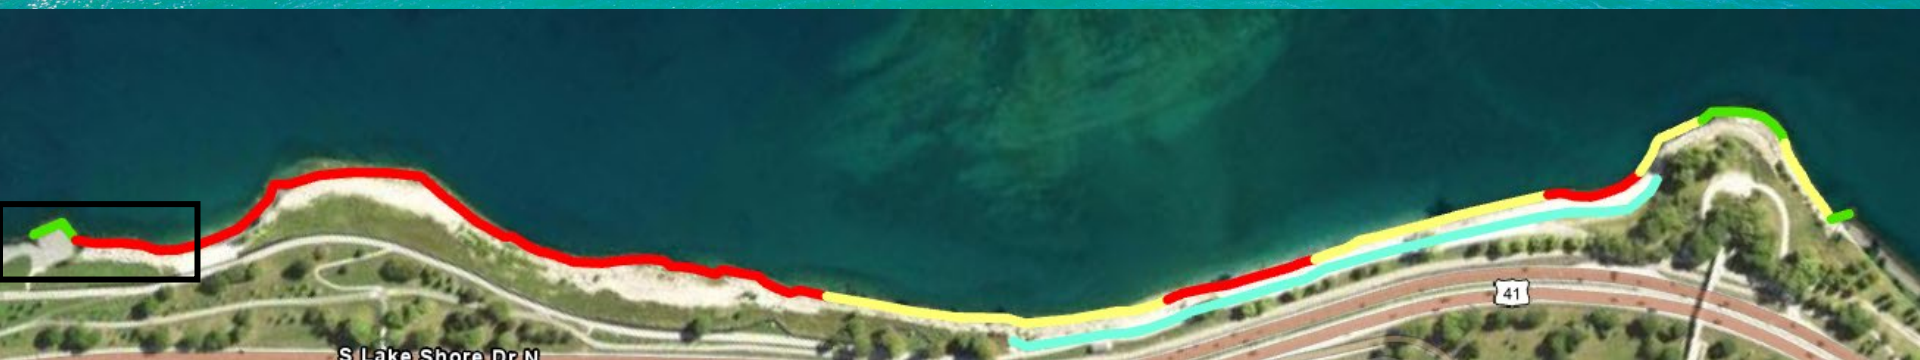
Functional Failure
1920's Limestone

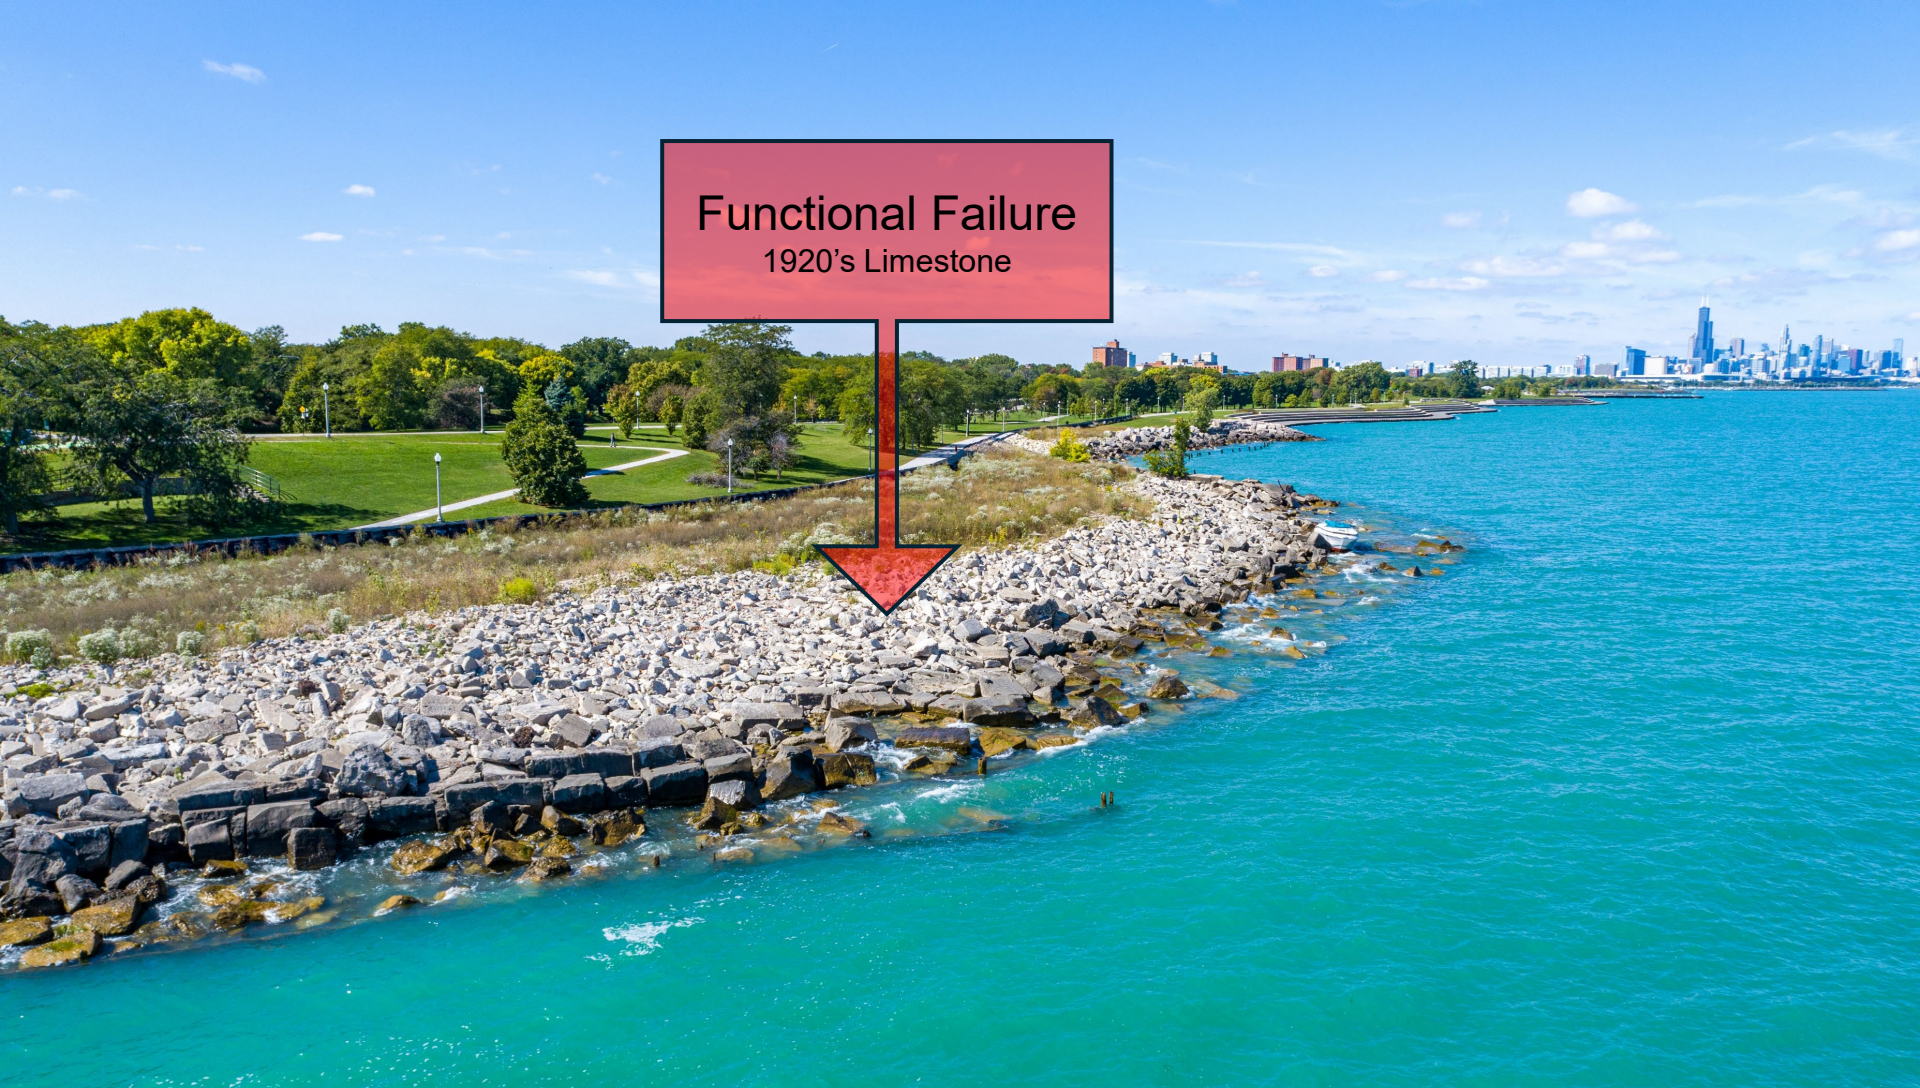
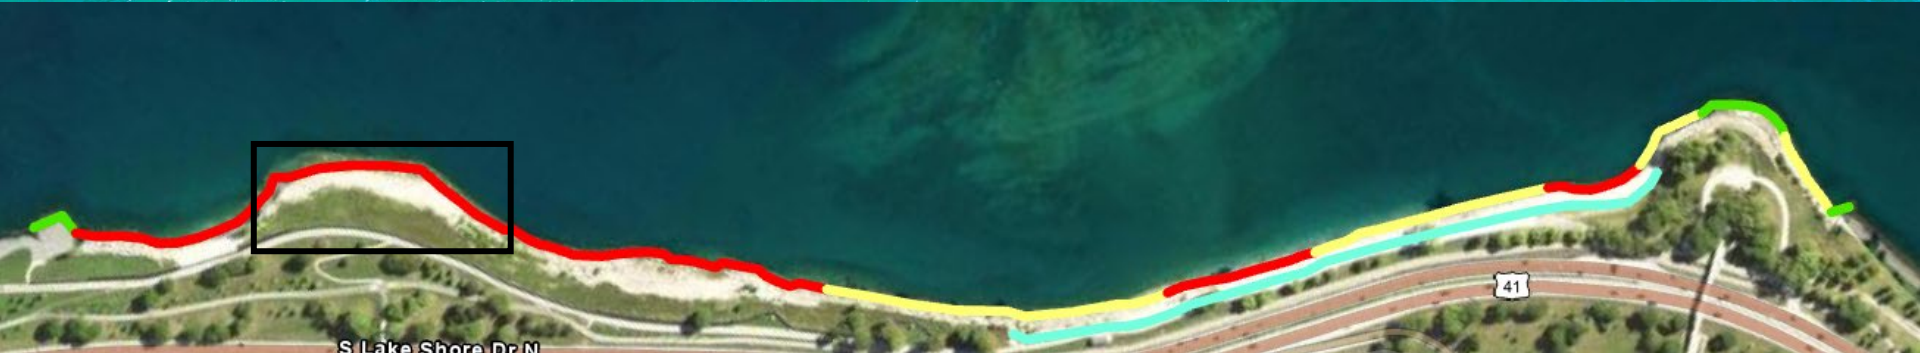
Functional Failure
1920's Limestone

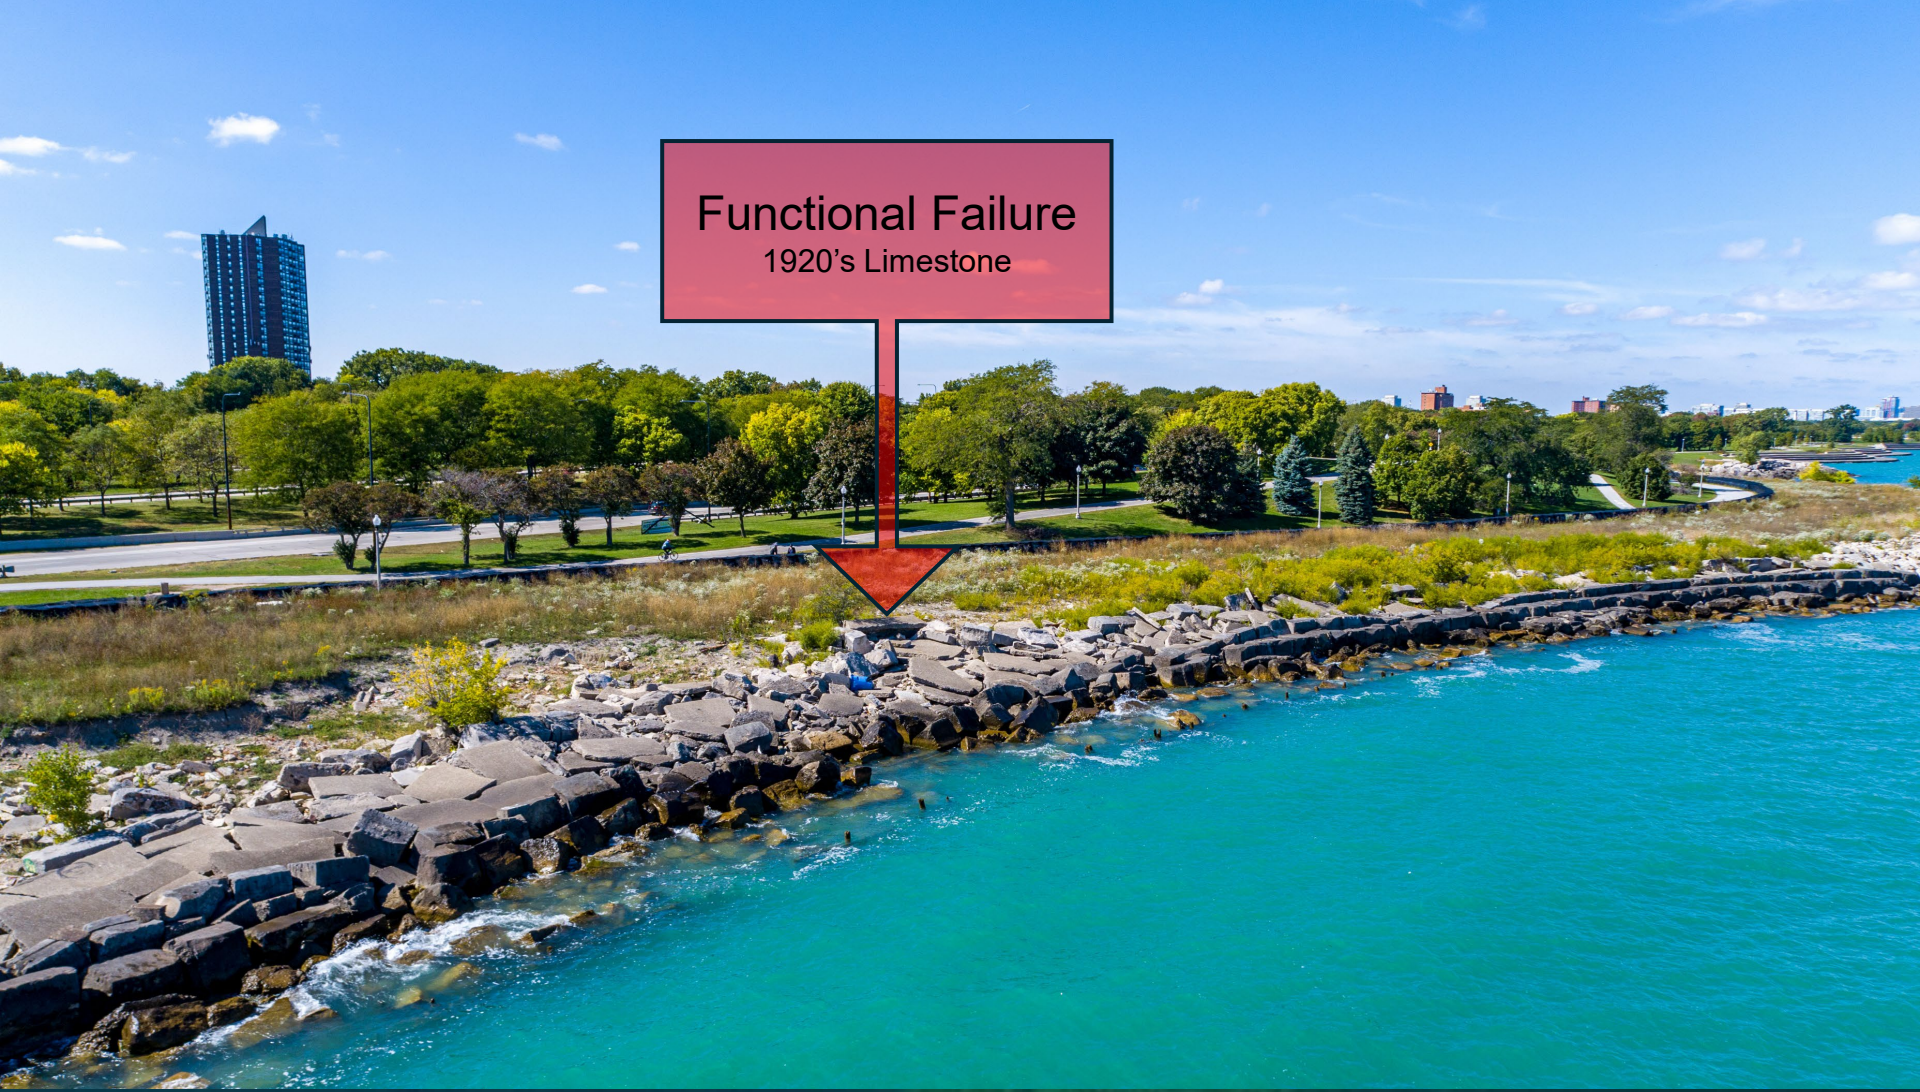
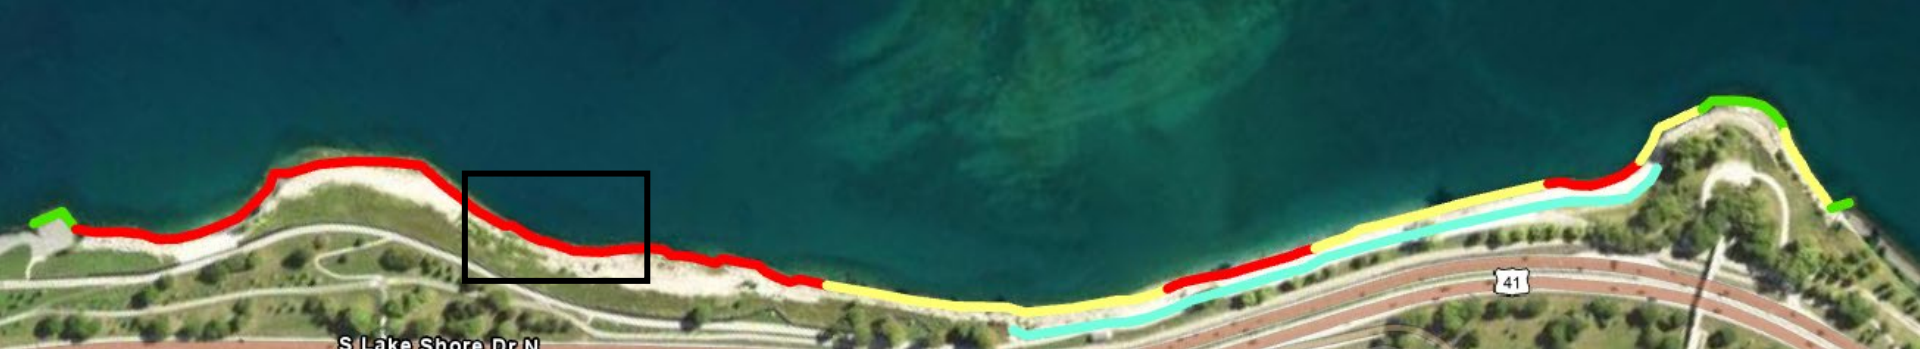
Functional Failure
1920's Limestone

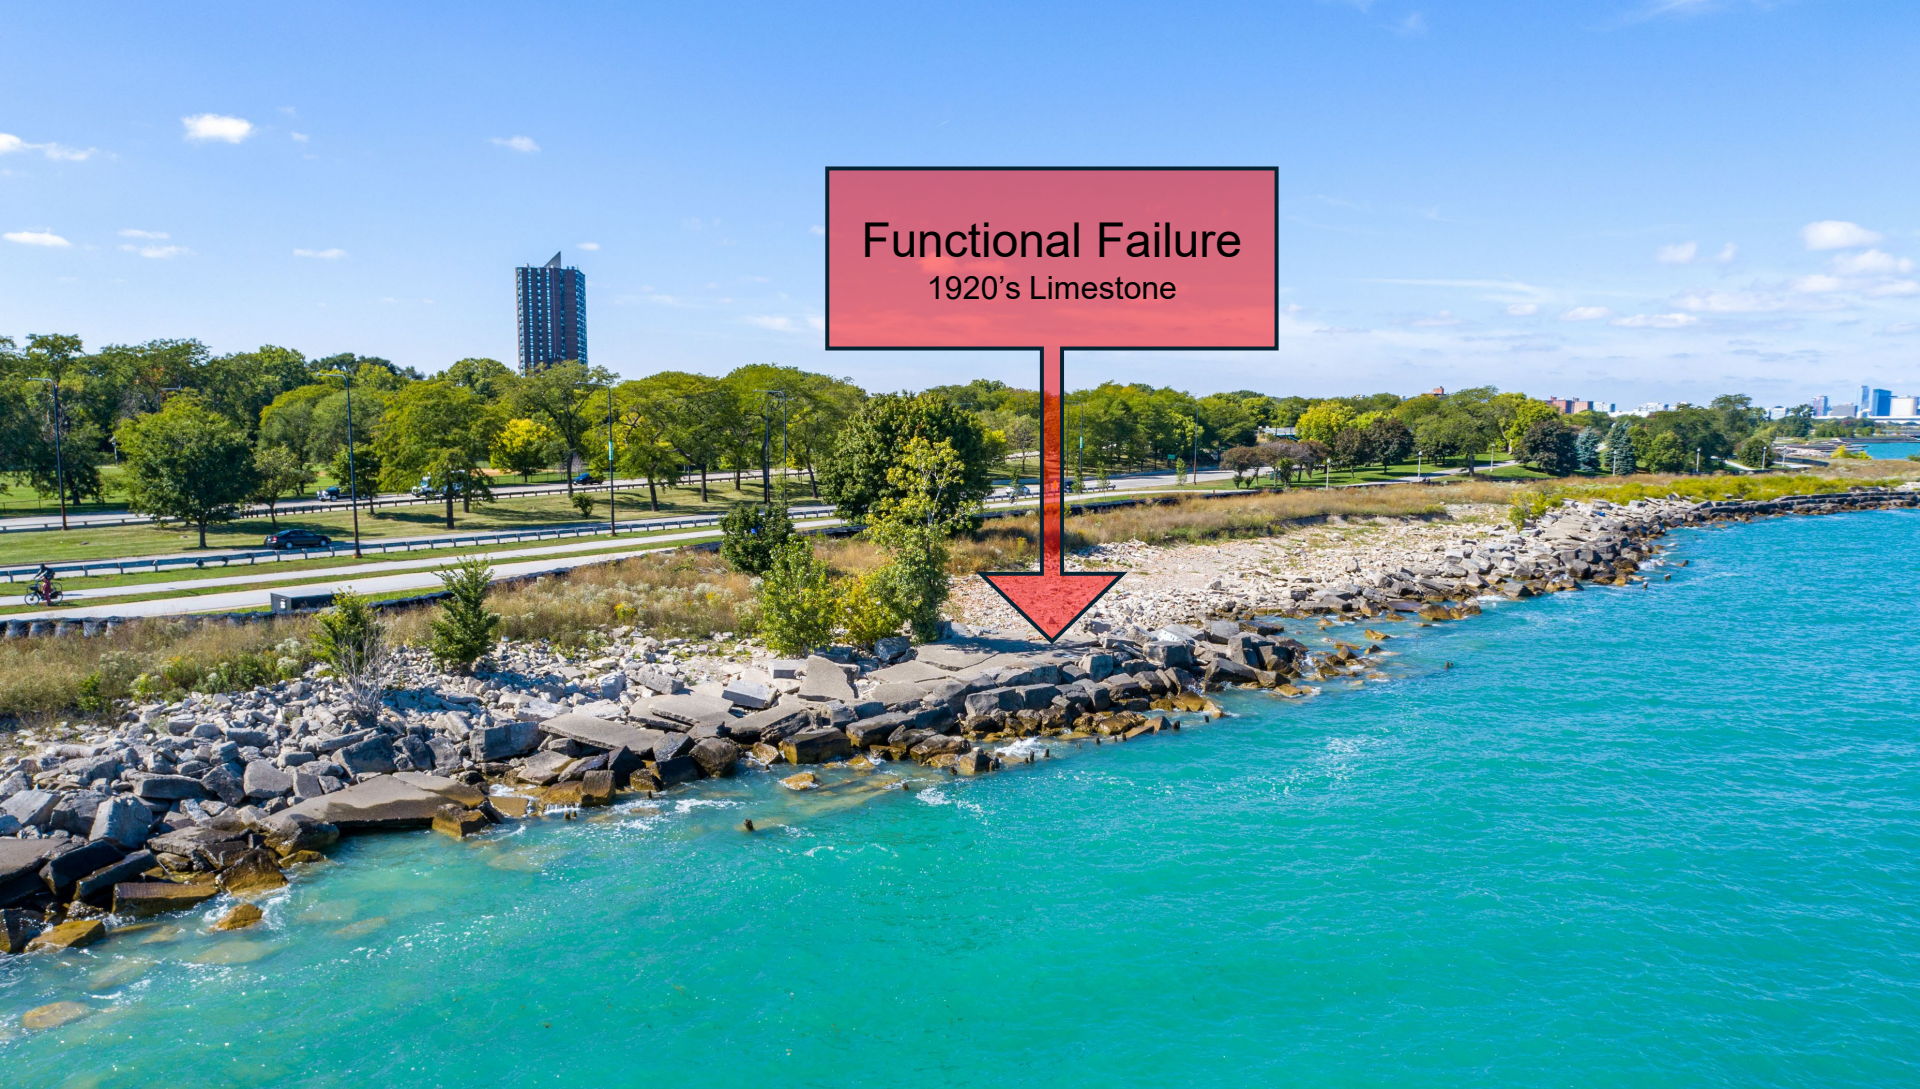
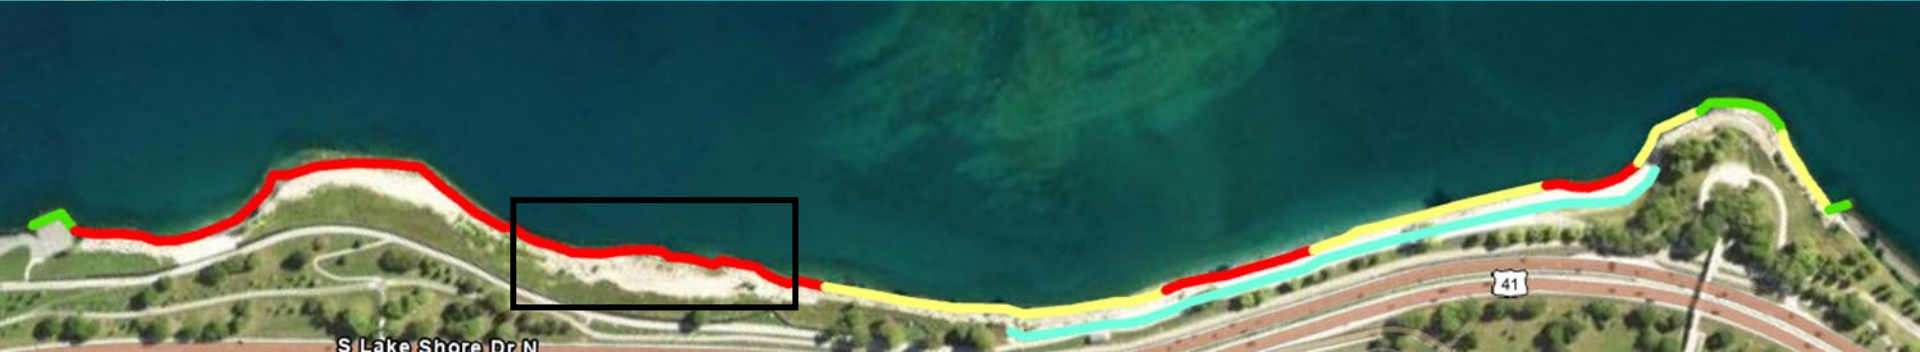
Structural Failure
1920's Limestone

Functional Failure
1920's Limestone

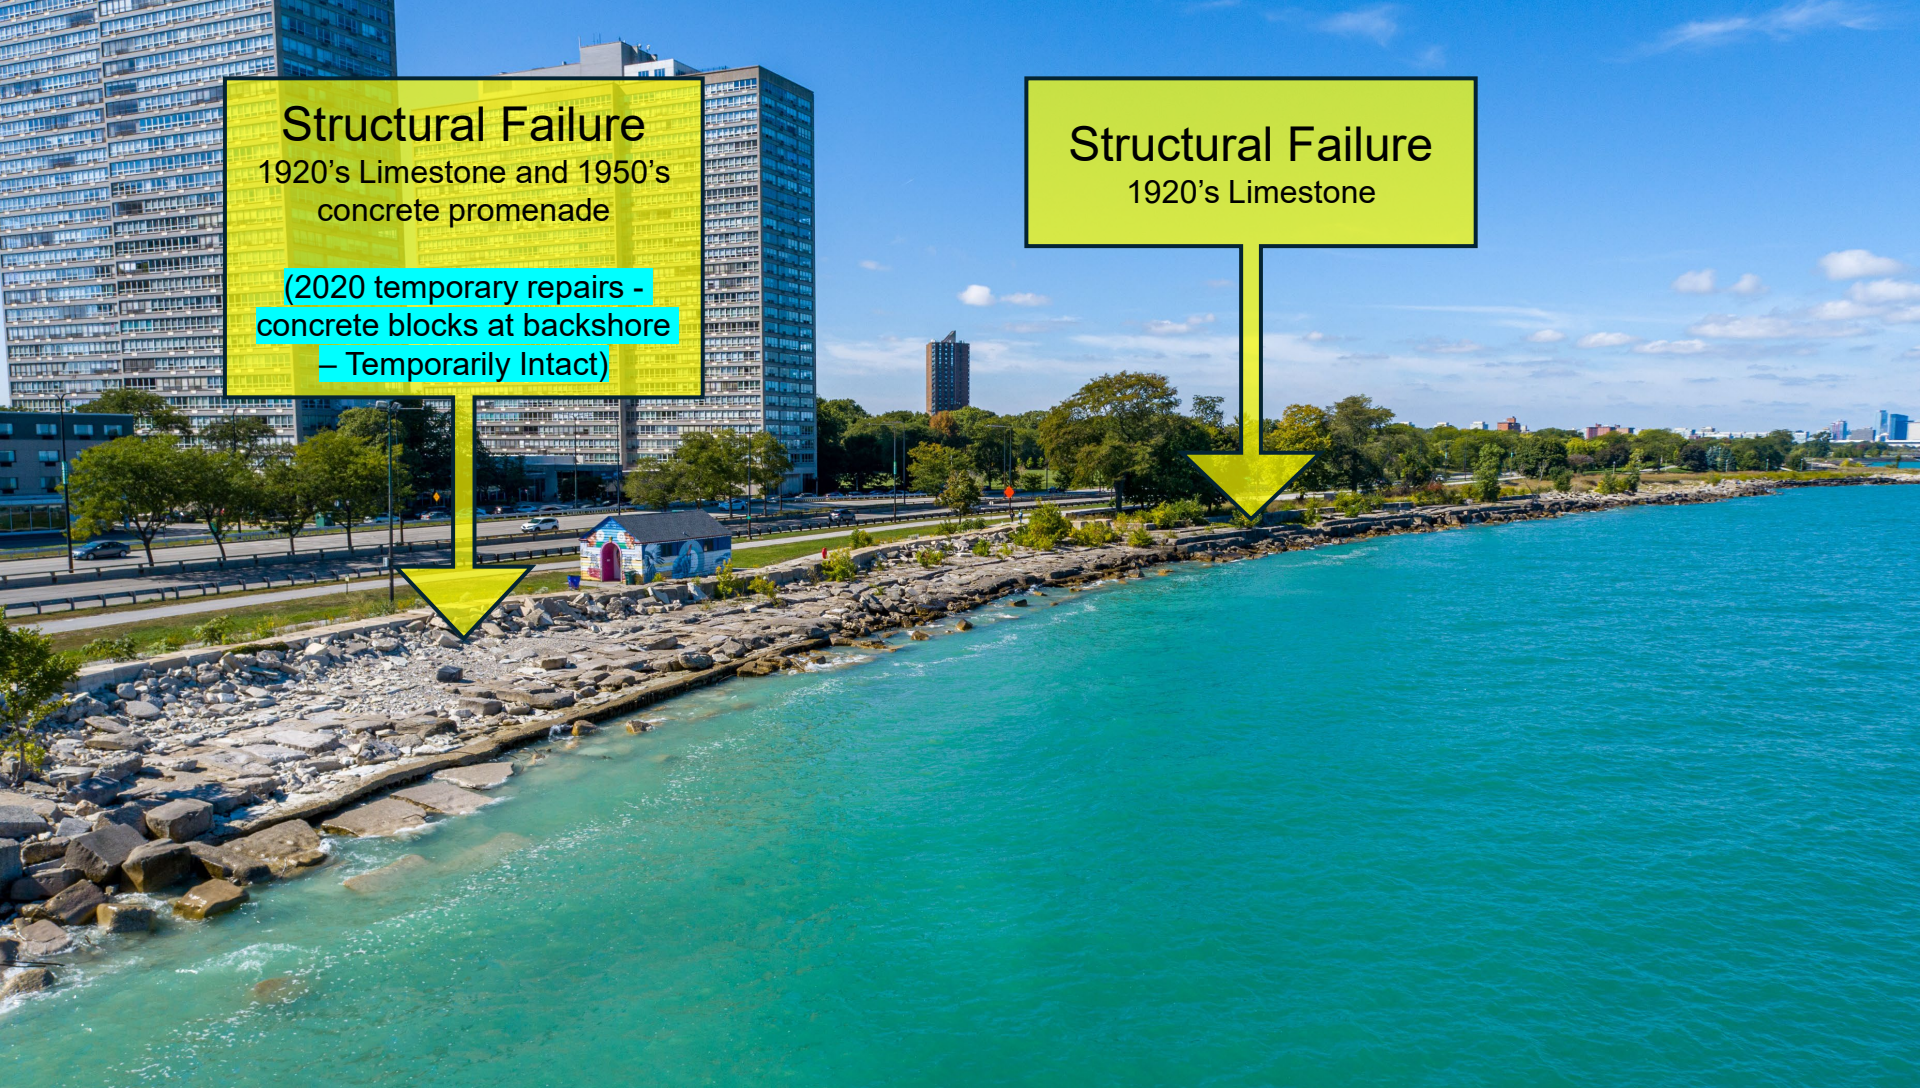
Structural Failure
1920's Limestone and 1950's
concrete promenade
**(2020 temporary repairs -
concrete blocks at backshore
- Temporarily Intact)**

Structural Failure
1920's Limestone

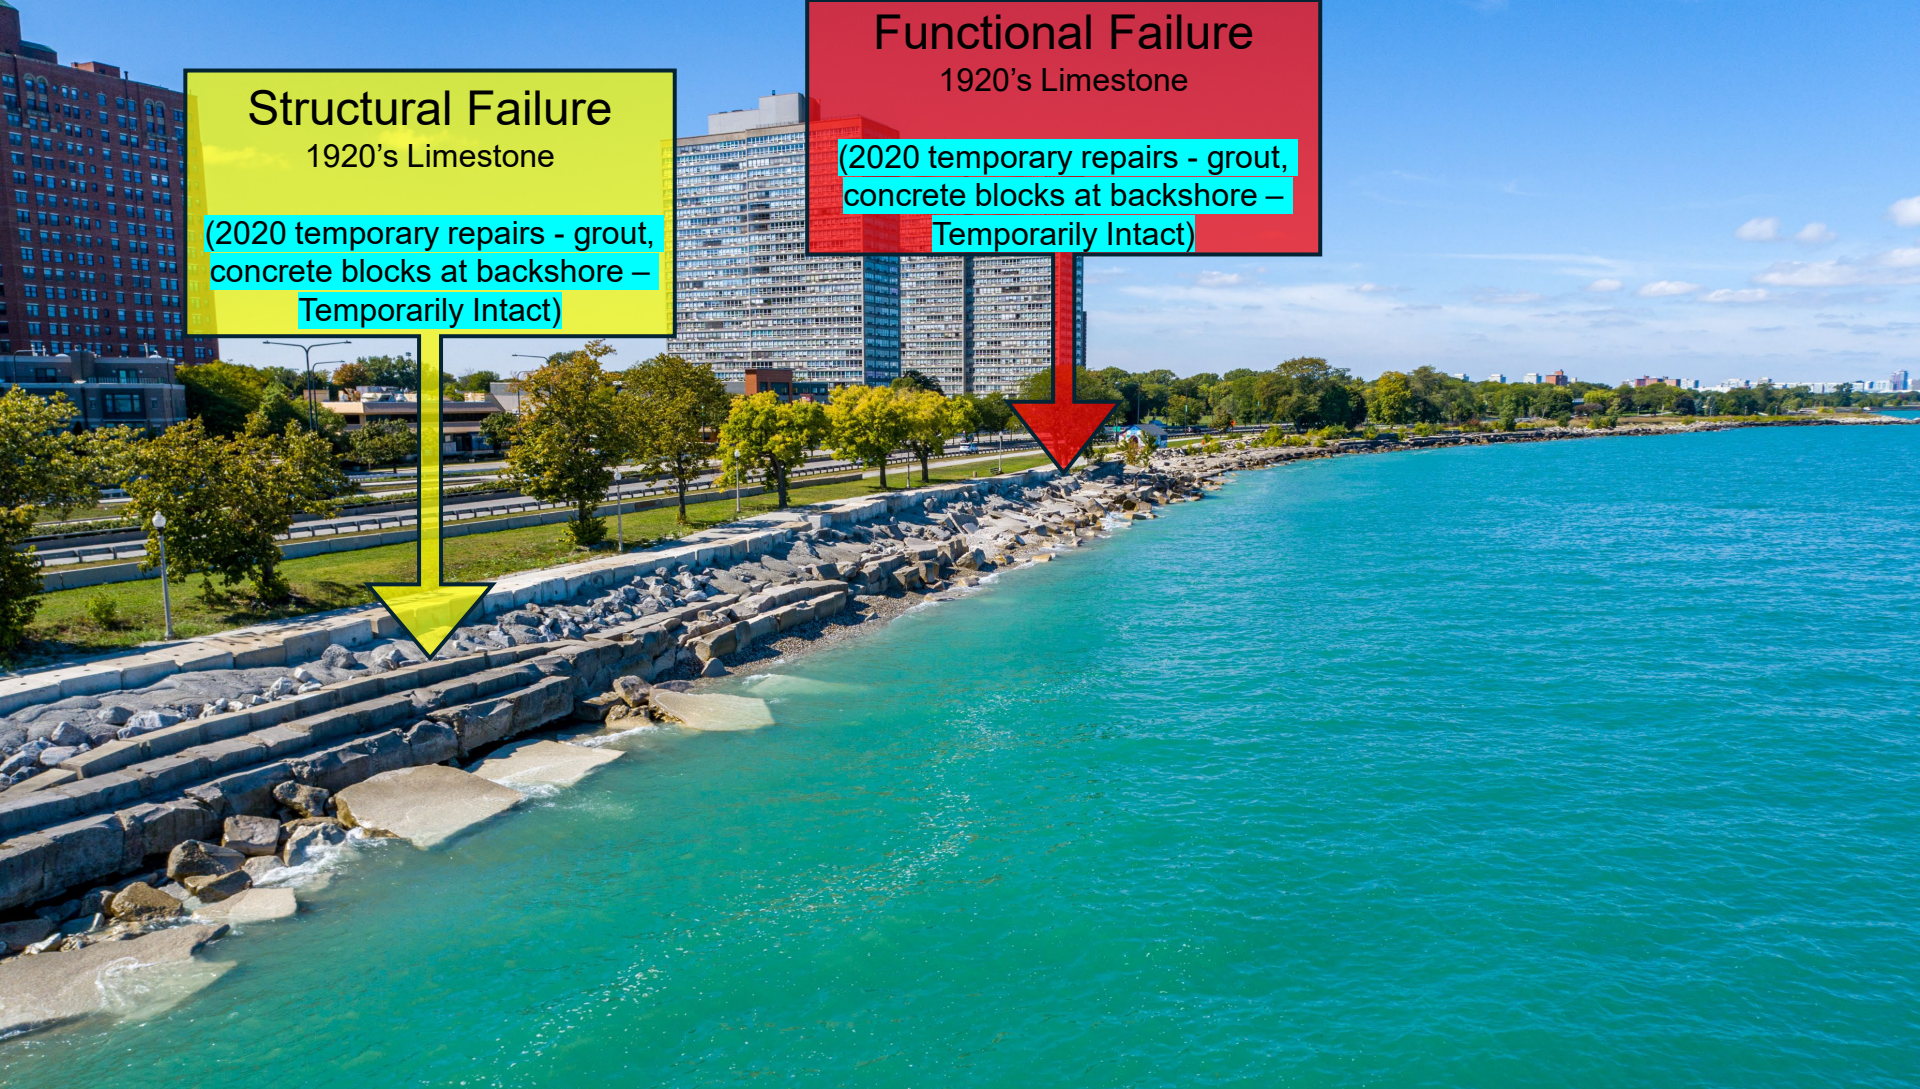
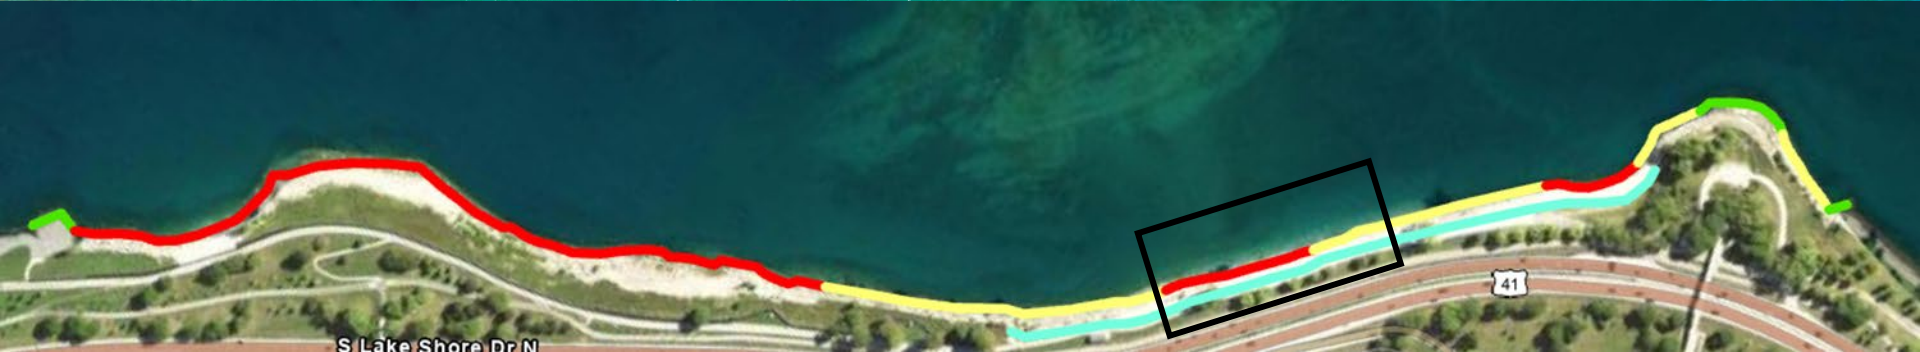
Structural Failure

1920's Limestone

(2020 temporary repairs - grout, concrete blocks at backshore – Temporarily Intact)

Functional Failure

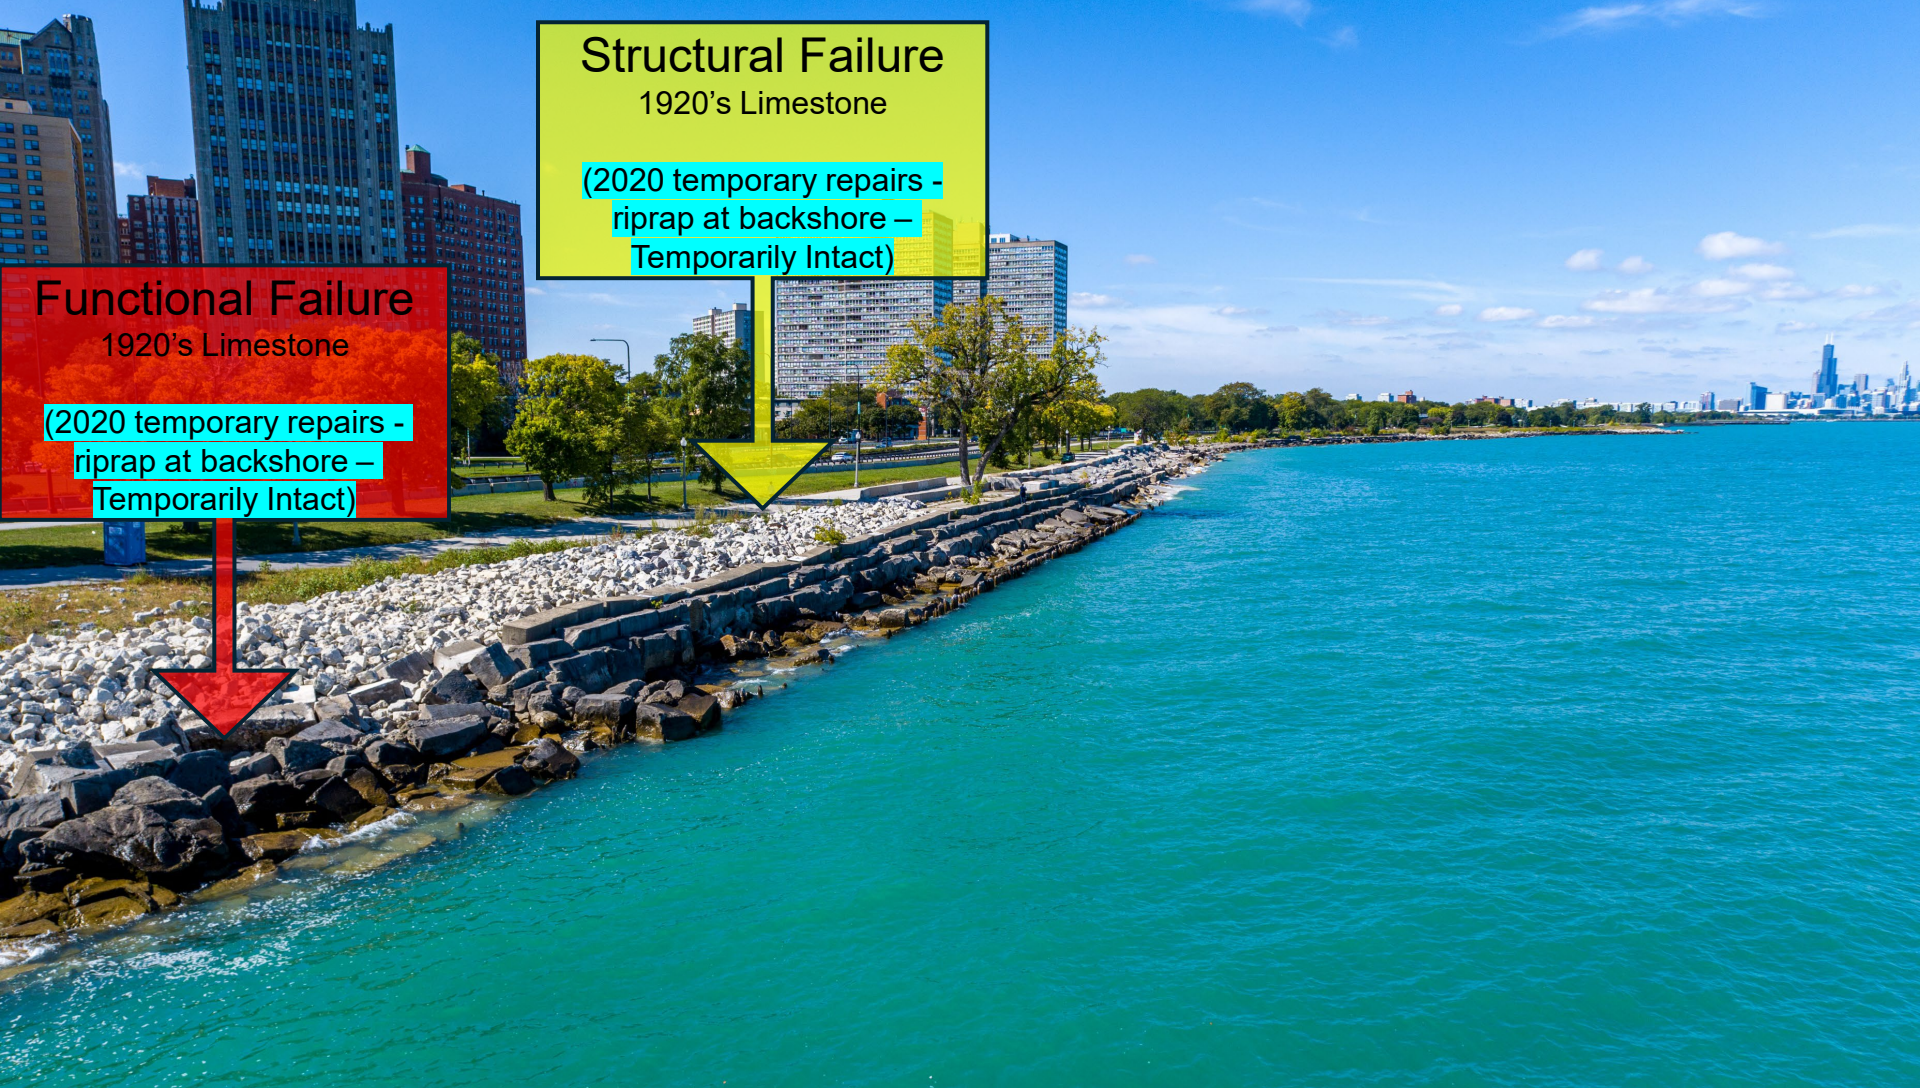
Structural Failure

1920's Limestone

(2020 temporary repairs -
riprap at backshore -
Temporarily Intact)

Functional Failure

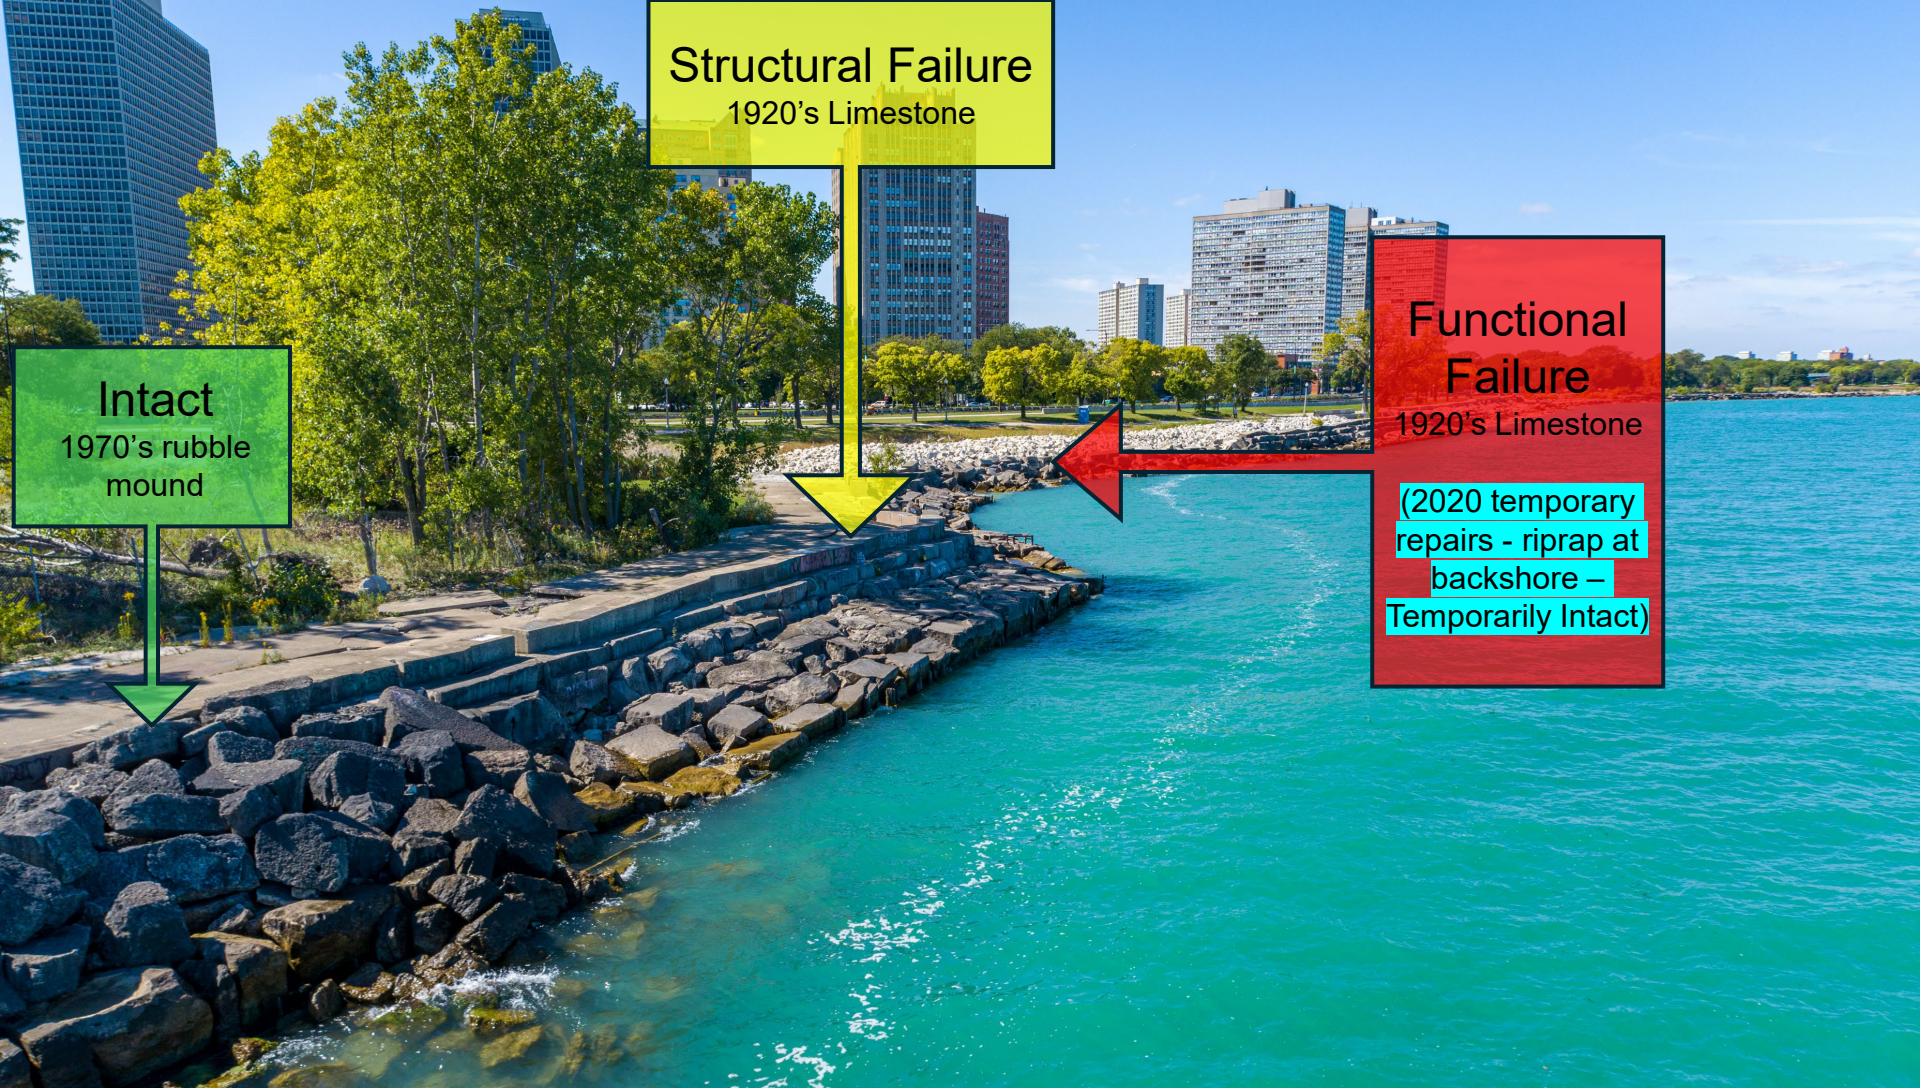
Structural Failure
1920's Limestone

Functional Failure
1920's Limestone
(2020 temporary repairs - riprap at backshore - Temporarily Intact)

Intact
1970's rubble mound
