**Roll-up of Articles  
January 2024**

## Shadow: NSN for Damaged or Unserviceable Dust/Weather Covers on the LID

# UH-60/AH-64: Complete and Report All SOF and ASAMs

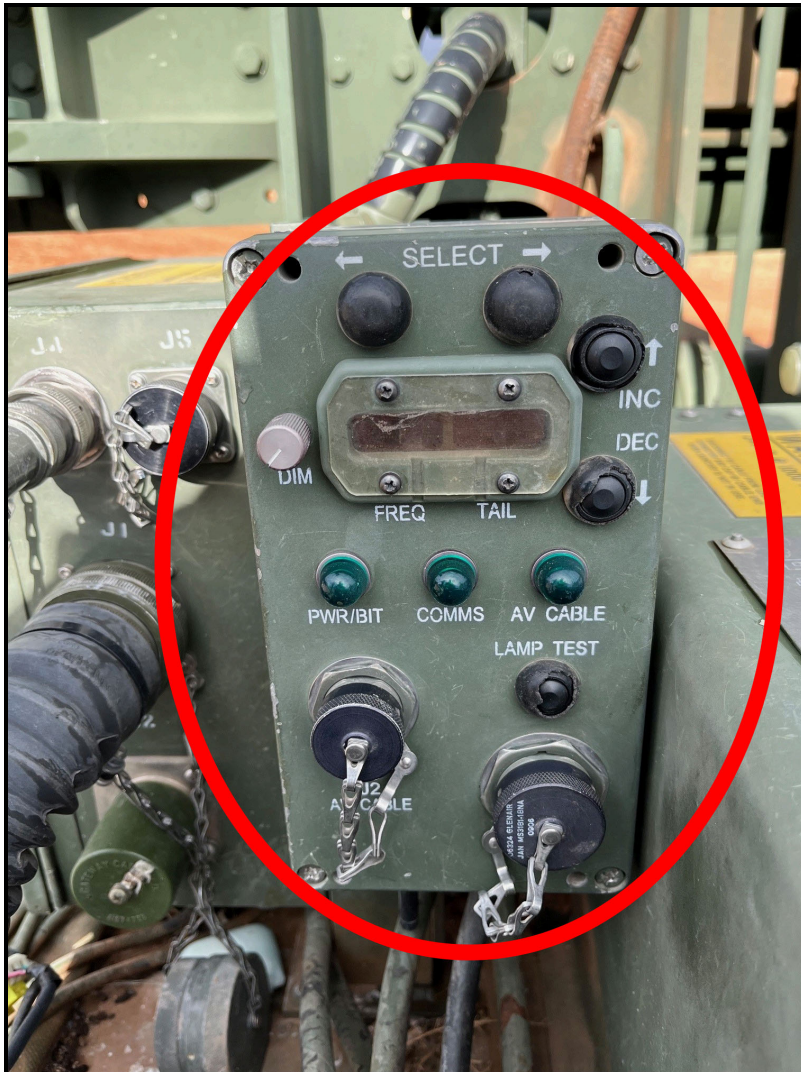
Replace damaged/unserviceable dust/weather covers or boots when worn or damaged

- 1. Remove Launcher Interlock Device (LID) per the TM.
- 2. With LID on work bench, remove Launcher Interlock Device (LID) front panel via four (4) screws per TM 1-1500-204-23. Retain screws.

- 3. Inspect each push-button (P/N ISR3SAD200) per TM 1-1500-204-23-4. No damage to the push-button allowed. Verify each push-button is functioning correctly per the TM. Replace as required.

- 4. If the push-button passes inspection, but requires a replacement boot, loosen the push-button locking nut that is located on the backside of the panel. If push-button locking nut is inaccessible, see below (Steps A through D).

- D. Loosen the push-button locking nut that is located on the backside of the panel.
- 5. Pull the push-button out past the panel far enough to give enough clearance to replace the damaged boot (P/N U5125-2). Replace the boot.

- 6. Re-install the push-button (P/N ISR3SAD200) into the LID front panel and tighten the push-button locking nut to the manufacturer's specs.

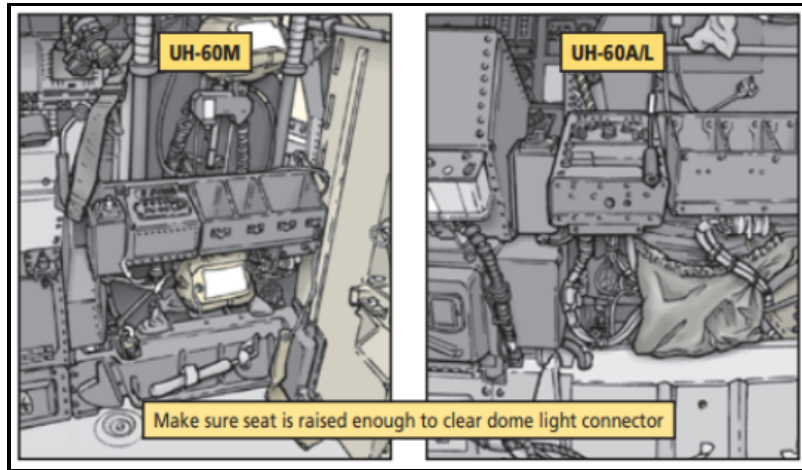
**Make sure seat is raised enough to clear dome light connector**

The only way to prevent tearing up the connector is to raise the seat up just enough for the headrest to clear the circuit breaker panel above, which provides clearance below for the dimming switch connector, then push the seat back completely. When

you tilt the seat back to the cabin floor, the connector will clear the box and it won't get damaged.

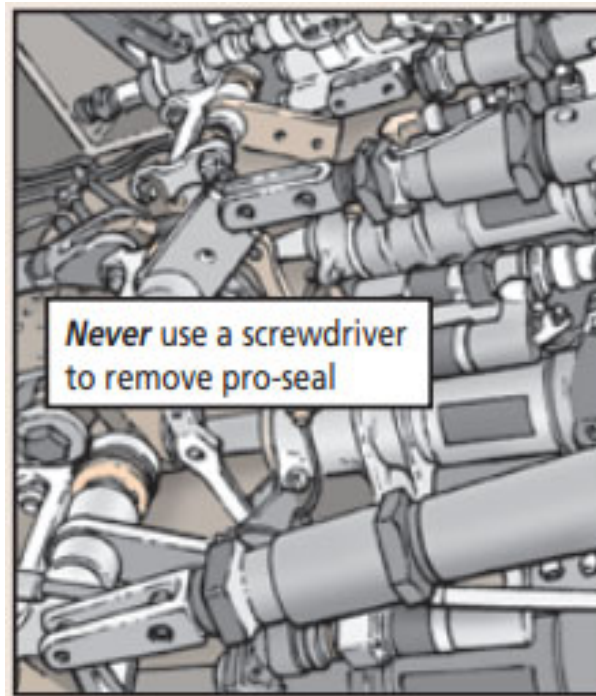
The knee jerk reaction is to grab a sturdy screwdriver or some other tool to start chipping away at the hardened pro-seal. Bad idea! Using screwdrivers to scrape off pro-seal leads to punching holes in the sheet metal and damaging parts. So don't do

### **Never use a screwdriver to remove pro-seal**

The correct way to remove pro-seal is with a non-metallic scraper. The correct way isn't always the easiest, but it's up to you to do maintenance right.

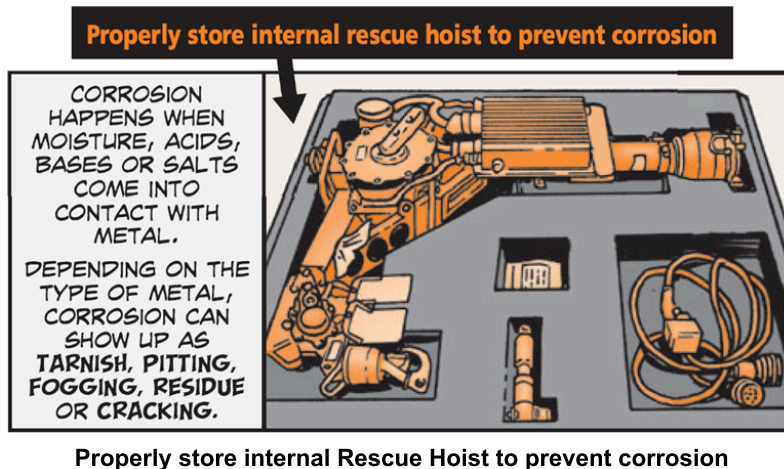
Unfortunately, IRHs are being neglected and stored in conditions that allow corrosion to spread rapidly. And with spare parts harder to get, preventing corrosion is more important than ever.

1. Control the storage environment. Keep IRHs dry and protected. Always store them in their containers and make sure the containers are properly fastened to keep moisture out. Store containers indoors when possible and always protect them from rain. The shipping and storage containers NSN is 8145-01-076-7476, PN CW5545-1505.
2. Use desiccants that are designed to absorb moisture and keep things dry. When storing an IRH, put large packs of desiccant inside the container to protect it from moisture that leads to corrosion.

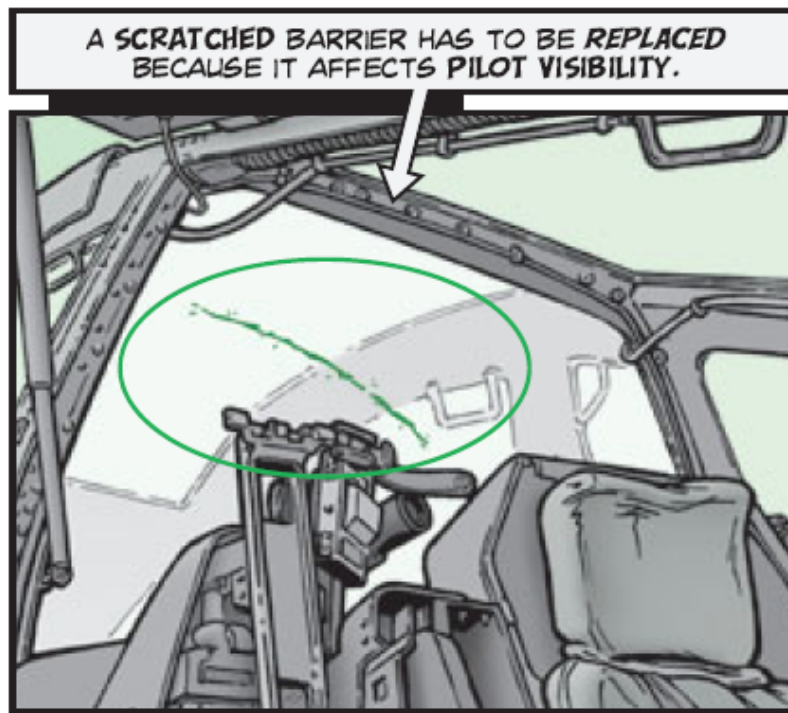
A scratched barrier has to be replaced because it affects pilot visibility

A new barrier costs \$7921.87 and requires two mechanics and about 16 hours to replace, so your unit takes a big hit. On top of that, the damage becomes a class D recordable incident because it exceeds \$5,000.

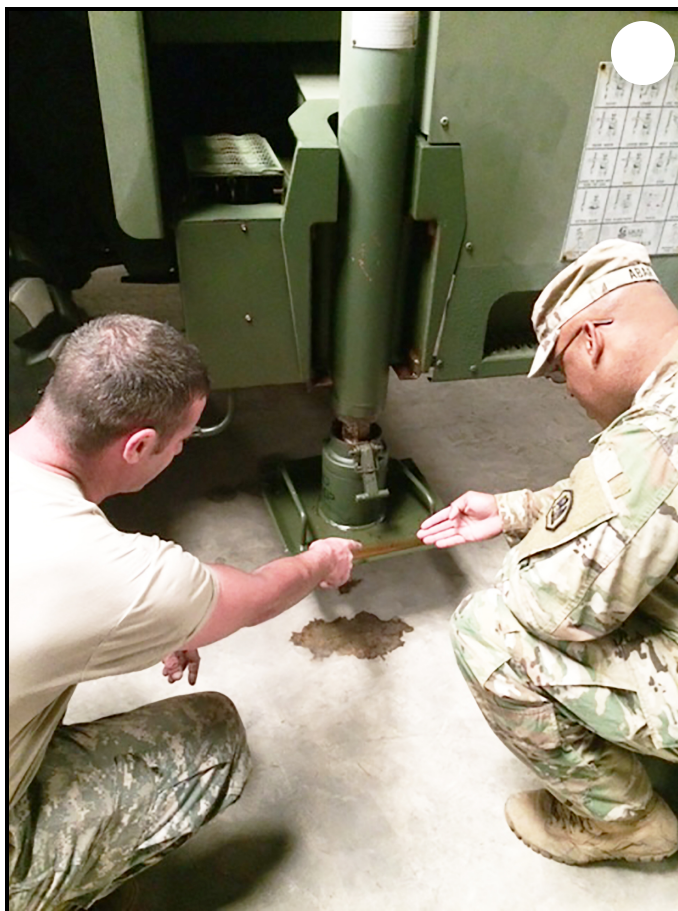
Operators, during your PMCS walkaround on the 22-ton crane, make sure you check for oil leaks around the vehicle's outrigger assemblies.

Exposure to the elements and plain old wear and tear cause leaks. Sometimes a

hose even comes loose.

A sure sign of a loose or leaky hose is oil pooling on the ground or on the outrigger's pad.

If you see a leak, report it.

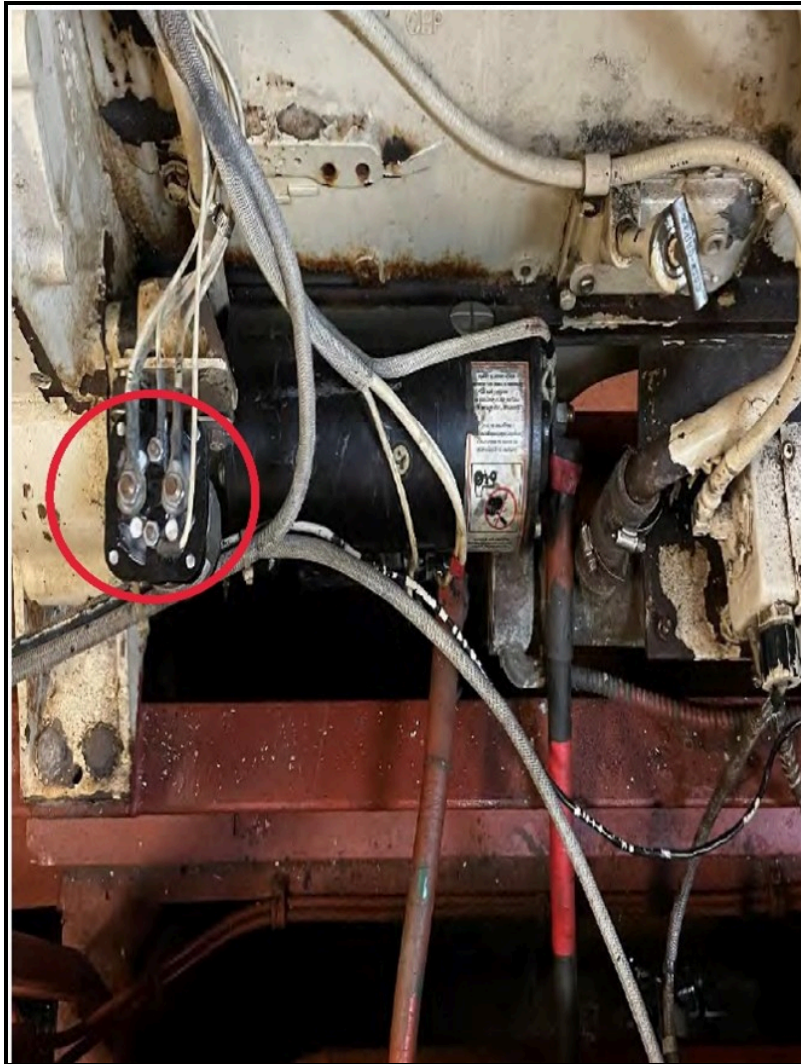
The exposed electrical connections on watercraft engines, in particular around the starters, are prone to shorting out. This is especially true when exposed to the weather.

Electrical shorts can be caused by condensation, as well as nuts and screws that are loose or improperly connected. Frayed connections and wires are another common culprit.

**Exposed electrical connections can short out**

The area around the batteries should always be kept dry. Positive and negative battery terminals should have boots placed on them, along with a light coat of grease, to help prevent corrosion.

Get a red positive battery terminal cover with NSN 5940-00-738-6272 and a black negative battery terminal cover with NSN 5999-01-382-8223.
