**Roll-up of Articles  
January 2024**

## Shadow: NSN for Damaged or Unserviceable Dust/Weather Covers on the LID

# UH-60/AH-64: Complete and Report All SOF and ASAMs

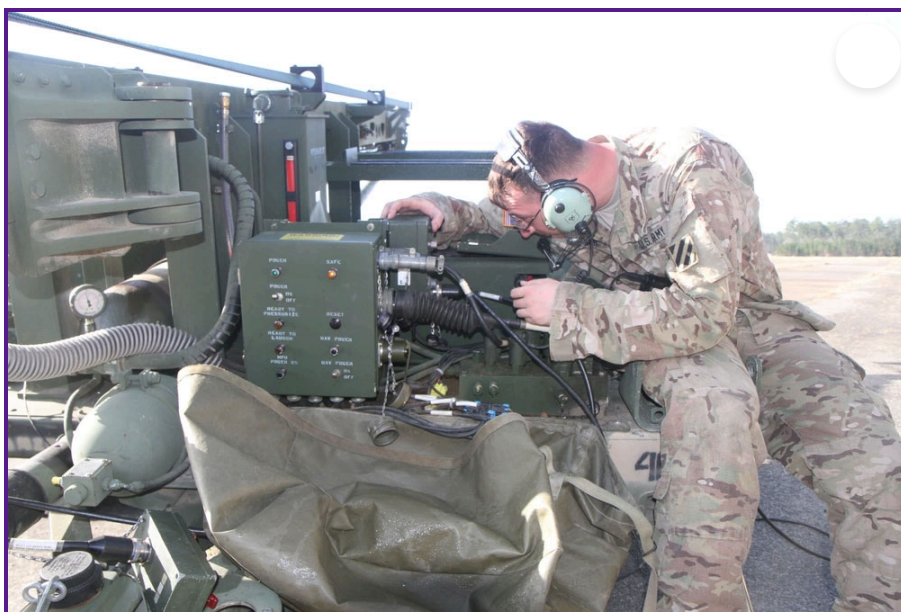
We're looking to replace the rubber dust/weather covers on the buttons of the launcher interlock device (LID) without having to replace the entire LID. We couldn't find a part number or NSN or procedure to replace these covers. The covers really help protect the buttons from the weather when the launchers are kept outside.

You're in luck. You can order the covers, known as sealing boots, with NSN 5930-01-570-6480, PN U5125-2.

Once received, follow the LID replacement procedures in the maintenance engineering call (MEC) [HERE](#).

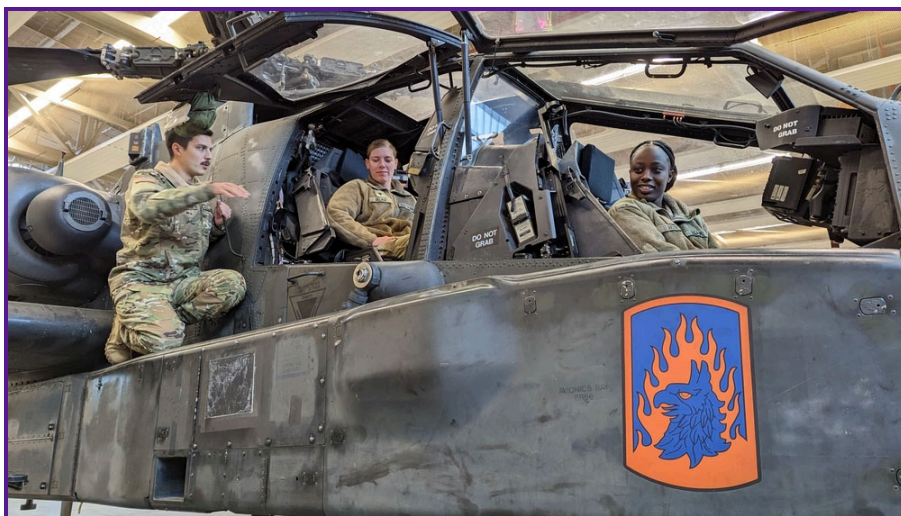
A scratched barrier has to be replaced because it affects pilot visibility

A new barrier costs \$7921.87 and requires two mechanics and about 16 hours to replace, so your unit takes a big hit. On top of that, the damage becomes a class D recordable incident because it exceeds \$5,000.

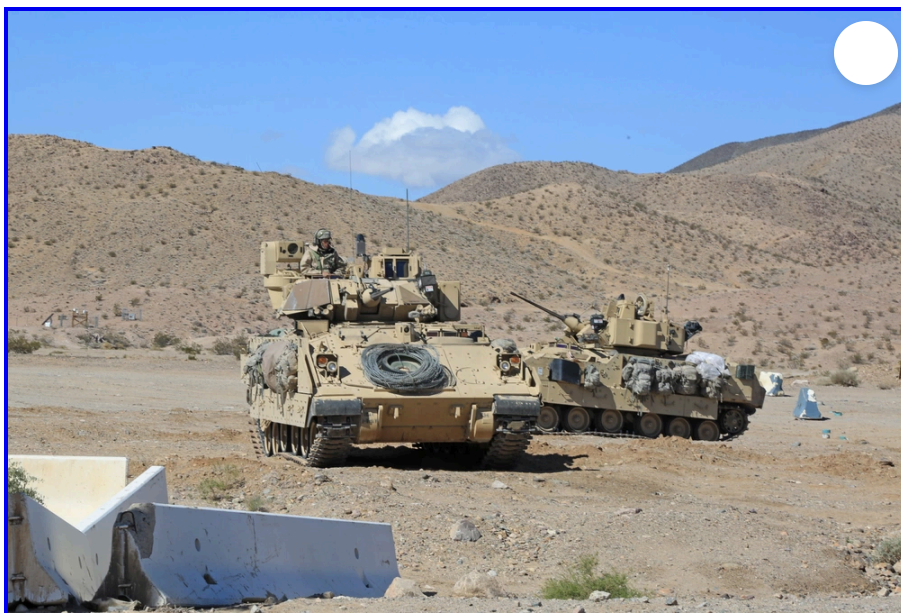
Crewman, be aware that the Bradley's driver's hatch cover can unexpectedly fall and seriously injure you or others if it isn't properly secured.

Always check the hatch cover before beginning operations to make sure it freely opens and closes, and that the safety latch locks in both the OPEN and CLOSED positions. If not, or if the safety latch is damaged or missing, let your mechanic know right away.

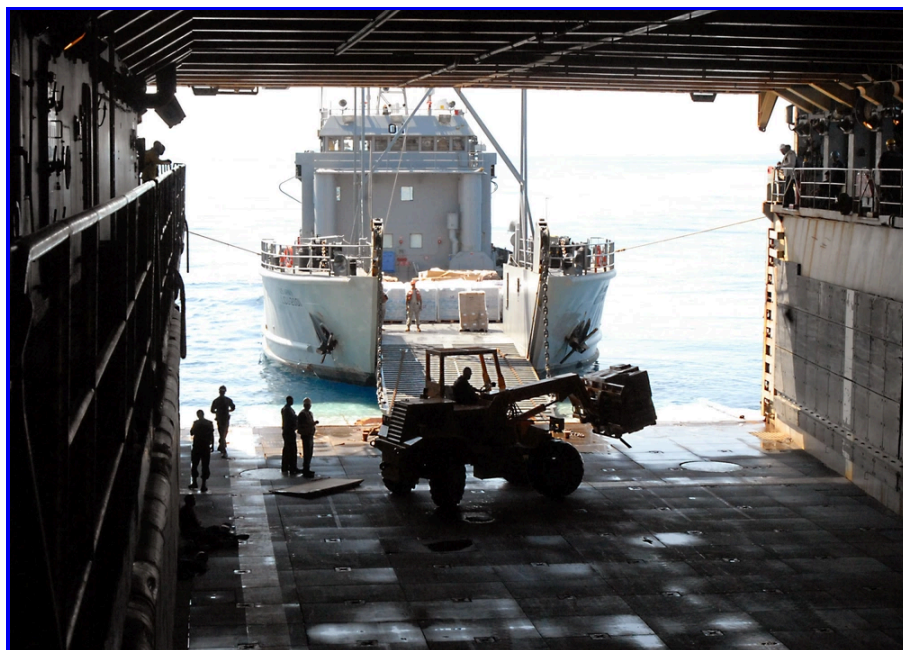
The exposed electrical connections on watercraft engines, in particular around the starters, are prone to shorting out. This is especially true when exposed to the weather.

Electrical shorts can be caused by condensation, as well as nuts and screws that are loose or improperly connected. Frayed connections and wires are another common culprit.

The area around the batteries should always be kept dry. Positive and negative battery terminals should have boots placed on them, along with a light coat of grease, to help prevent corrosion.
