Appendix F – Coastal Shoreline Condition

Draft Supplemental Environmental Assessment
Morgan Shoal Revetment Reconstruction (45th - 51st Street)

Coastal Shoreline Condition Morgan Shoal 2025

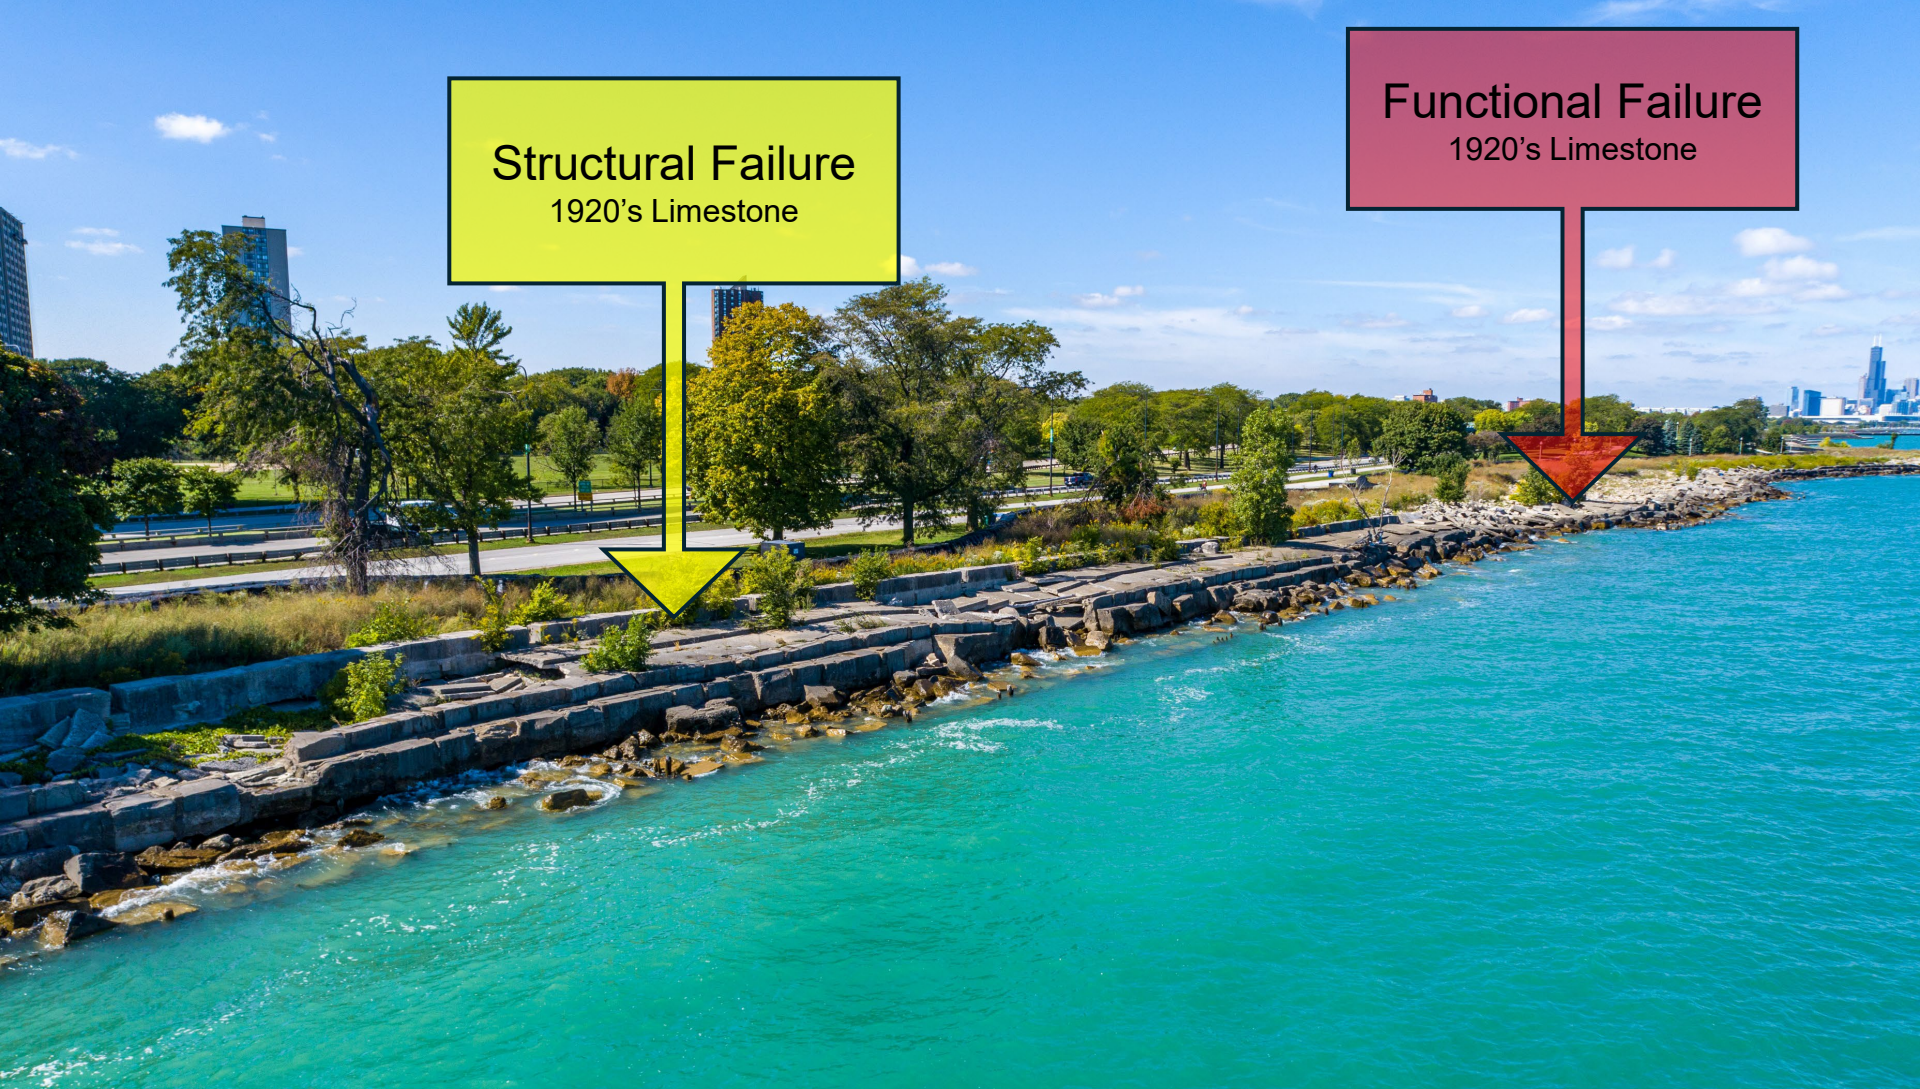
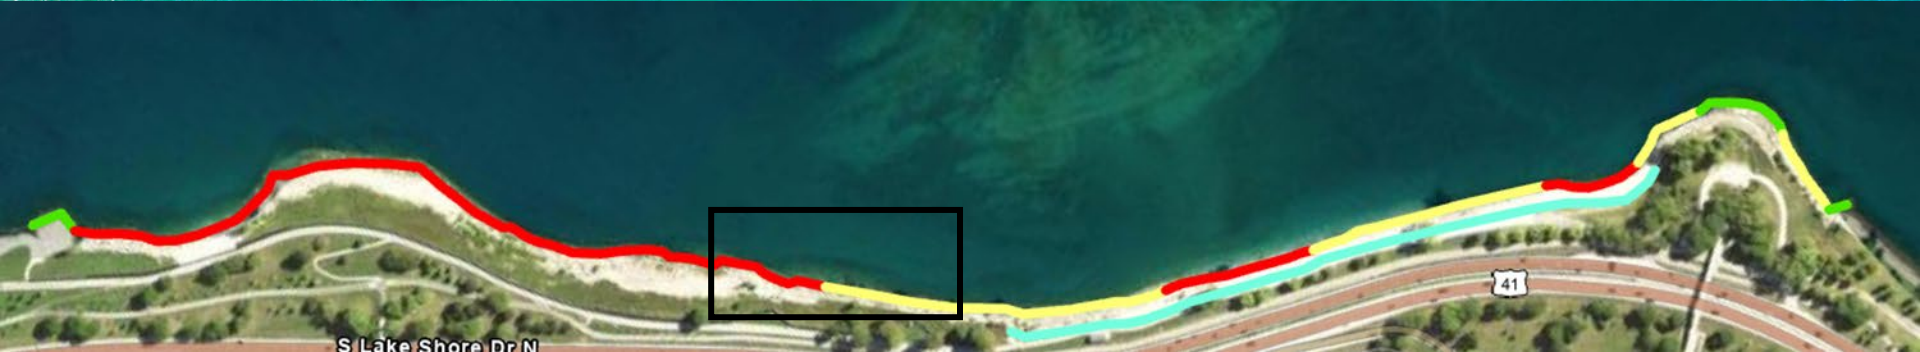
Structural Failure
1920's Limestone

Functional Failure
1920's Limestone

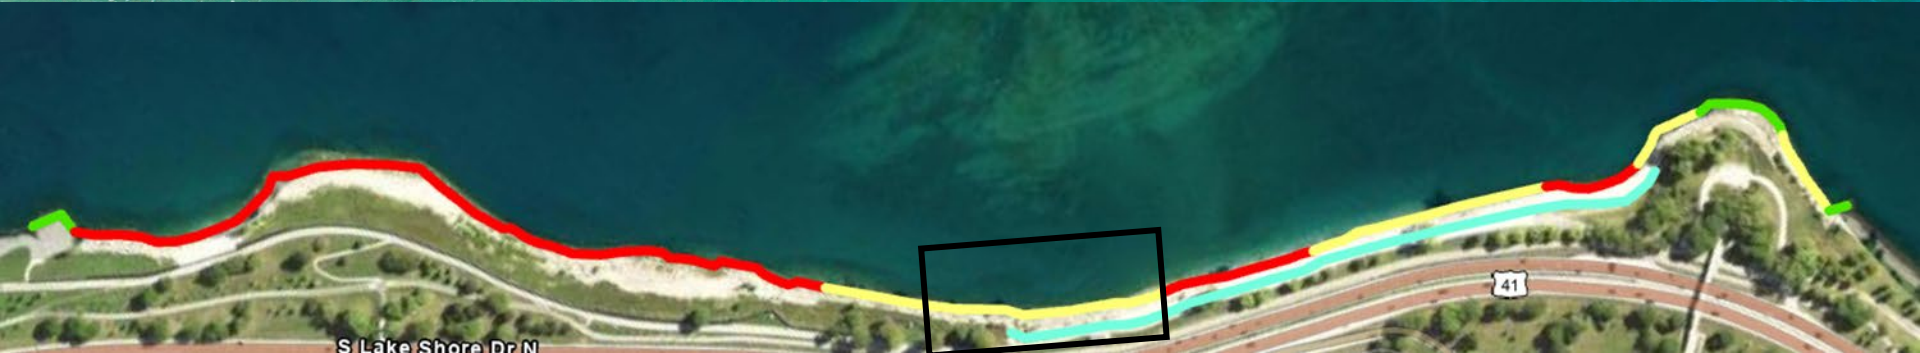
Structural Failure
1920's Limestone and 1950's
concrete promenade
**(2020 temporary repairs -
concrete blocks at backshore
- Temporarily Intact)**

Structural Failure
1920's Limestone

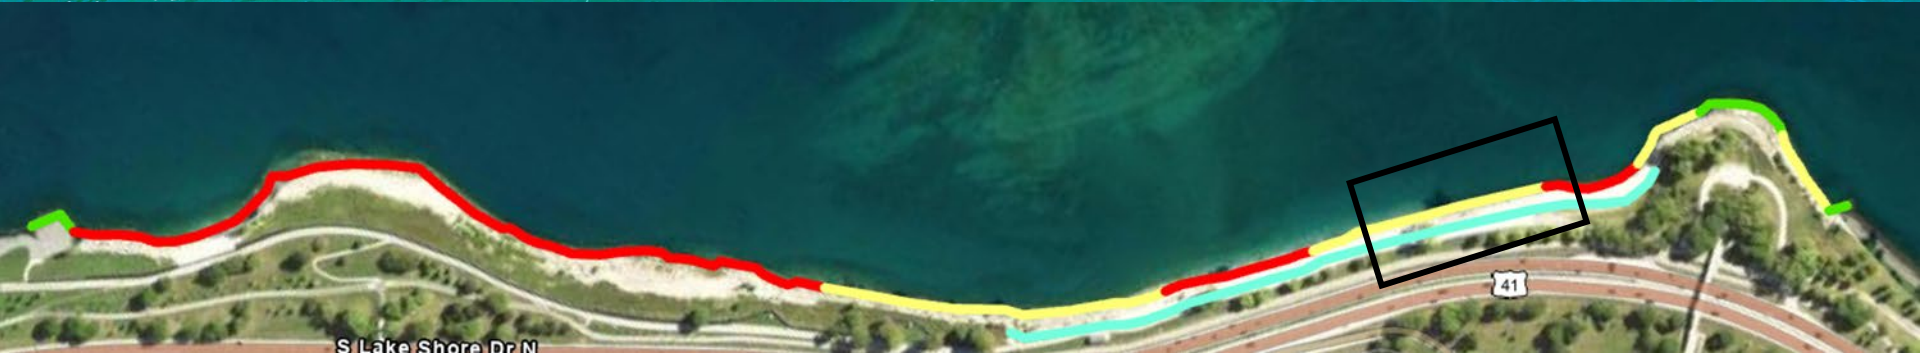
Functional Failure

1920's Limestone

(2020 temporary repairs -
riprap at backshore -
Temporarily Intact)

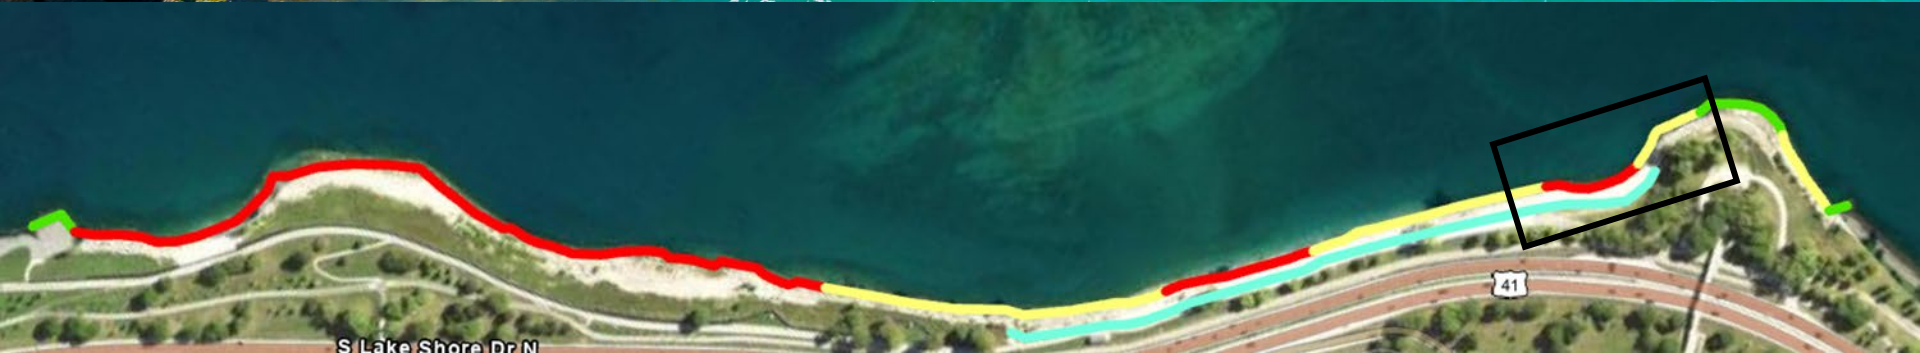
Structural Failure
1920's Limestone

Functional Failure
1920's Limestone
(2020 temporary repairs - riprap at backshore - Temporarily Intact)

Intact
1970's rubble mound
