THE NAVY AND MARINE CORPS AVIATION SAFETY MAGAZINE

Approach

VOL. 64, NO. 2

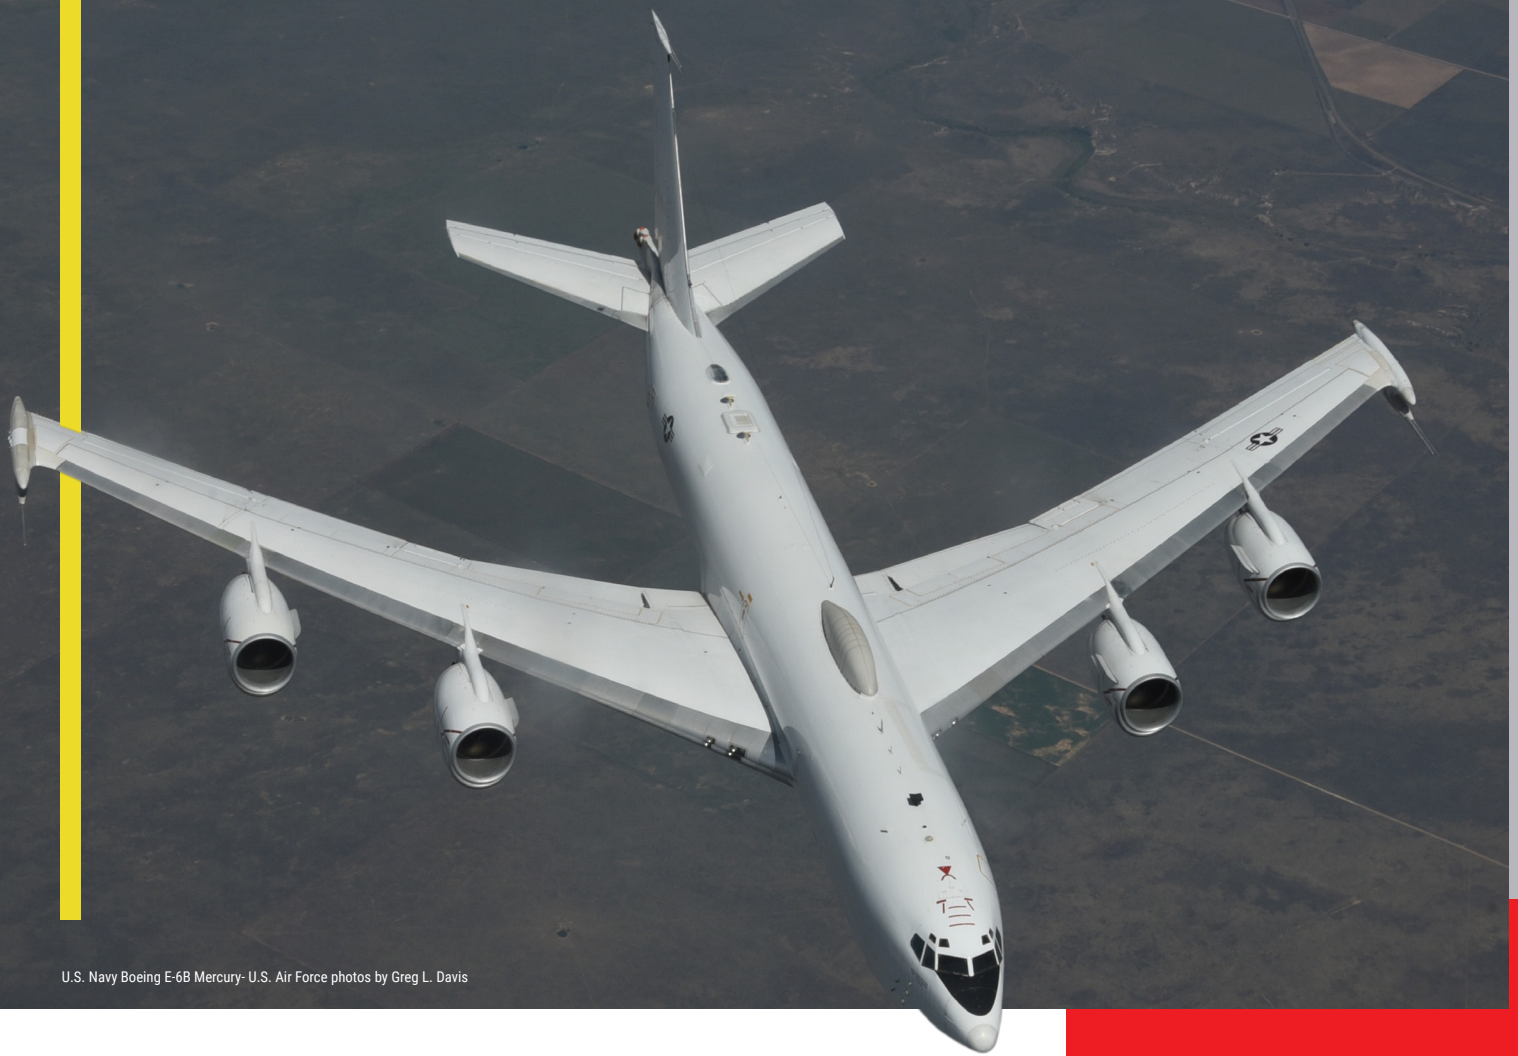
U.S. Navy Boeing E-6B Mercury- U.S. Air Force photos by Greg L. Davis

An FE-T may not recognize this among the vast sea of gauges and dials that make up the E-6B Mercury flight engineer panel, but because a thorough and consistent scan of instruments was conducted, ours did. Upon further examination, it was evident to the FE-T that oil quantity was steadily decreasing.

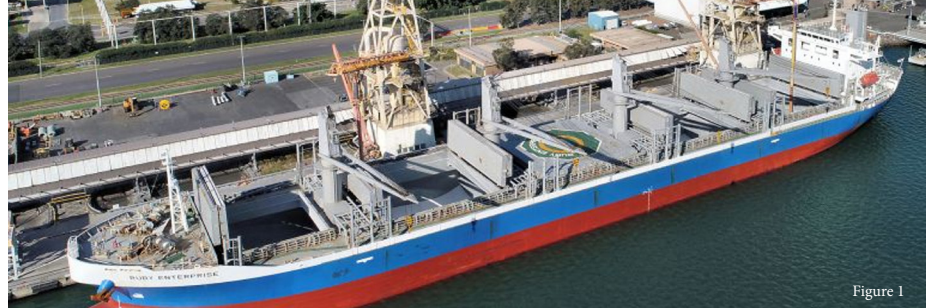
Figure 1

Pre-mission analysis of the possible injuries the patient could have sustained, including the interventions available and time required for crewmembers on deck, were briefed with the entire crew. By planning the prospective rescue step-by-step, a bingo corresponding to 20 minutes on deck was established and monitored by all members of the crew. Two locations on the vessel were deemed suitable for hoisting: a mid-deck location flanked between two 80-foot cranes (primary site) and an aft site proximal to the mainmast (secondary site) (figure 1).

Cargo vessels of this configuration typically offer two suitable locations for hoisting: main

deck and aft deck. Main-deck transfers have the advantage of offering a wider available space to maneuver but may feature hazardous obstacles requiring consideration. Aft-deck transfers are generally free of obstructions but have limited maneuver space due to proximity to the ship’s masthead and funnel, requiring the crew chief to “swing” the rescuer onto the ship if the aircraft cannot maneuver directly over the aft deck.

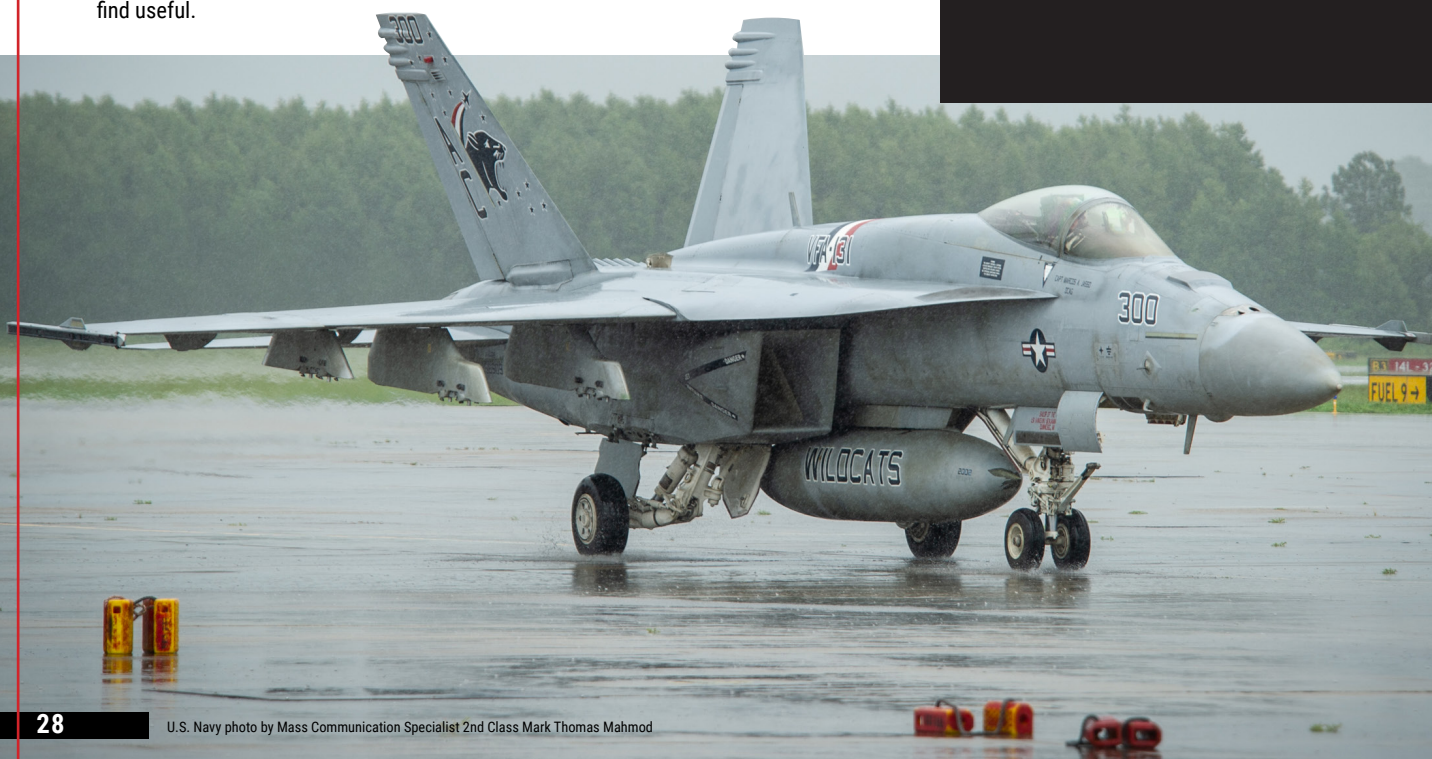
Next, I raised the flaps and attempted to turn off the landing / taxi light. In the F/A-18A-G the landing / taxi light and launch bar switches are roughly similar in shape with the launch bar switch being smooth and located directly above the landing / taxi light switch.

As these two switches are located in approximately the same location and are roughly similar, the landing and taxi light switch has two small "domes" on it to help differentiate it from the launch bar switch by feel.

The Launch Bar switch also requires the pilot to pull it out of a detent before moving it to the "Up" or "Down" position. In my attempt to turn off the Landing / Taxi light, I had inadvertently grabbed the Launch Bar switch and placed it in the "DOWN" position. When the switch is placed in the "DOWN" position, normal NWS immediately disengages and can only be reengaged by depressing the NWS button on the stick. Normally, pressing and holding the NWS button a second time will provide high gain NWS, but with the Launch Bar down, the pilot can only select a maximum of low gain NWS. Low gain NWS allows for plus or minus 22.5 degrees of nose wheel travel to the left and right while high gain allows plus or minus 75 degrees of nose wheel travel.

Since the Launch Bar was now down, I was only able to select low gain NWS even with the high gain NWS button depressed and held. This led to my assessment that I wasn't generating the desired turn rate with high gain NWS as expected during my turn on the main taxiway, which indicated a possible issue.
