# Approach

2022, Vol. 65, No. 1 - [www.navalcommand.navy.mil](http://www.navalcommand.navy.mil)

## ERGONOMICS EFFECTS ON UAS DEPLOYMENT

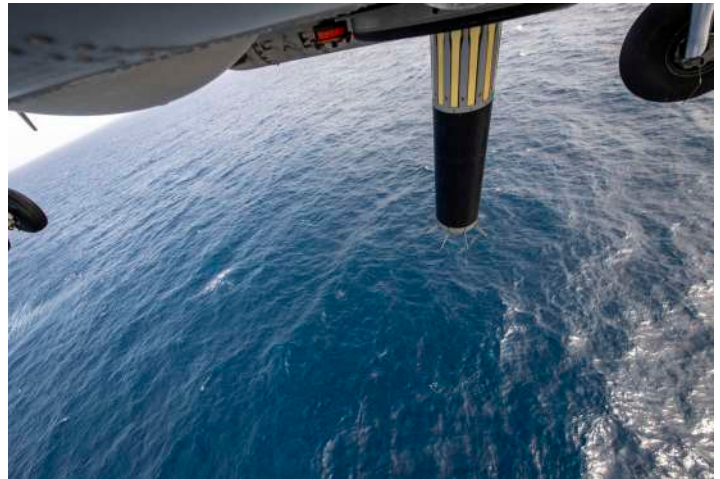
The sonar dipping transducer of an MH-60R Seahawk, attached to the "Saberhawks" of Helicopter Maritime Strike Squadron (HSM) 77, assigned to USS Shiloh (CG 67) is hoisted during an subsurface detection exercise evolution, June 23, 2021. (U.S. Navy Photo by Mass Communication Specialist 1st Class Rawad Madanat)
