— THE NAVY AND MARINE CORPS AVIATION SAFETY MAGAZINE —

# Approach

VOL. 65, NO. 3

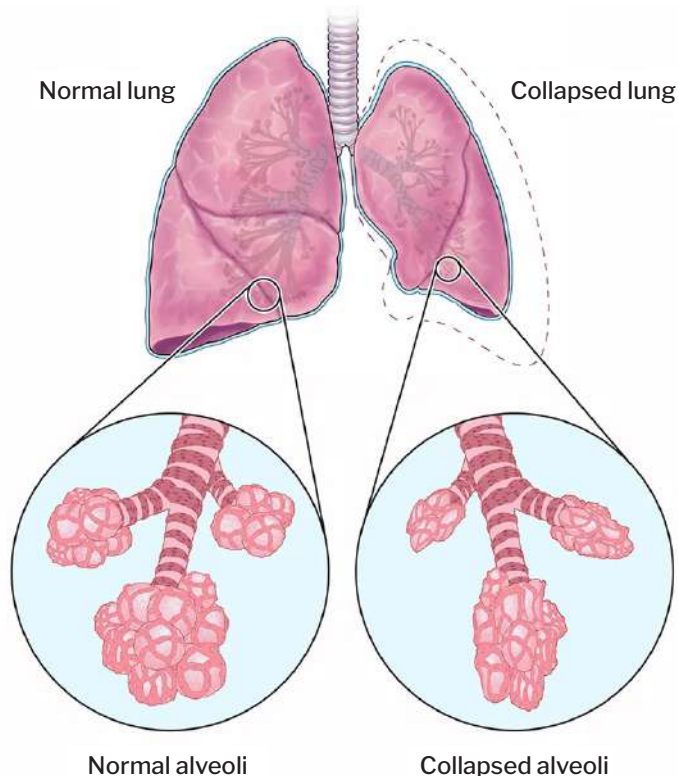
**Atelectasis in the lung(s) leads to the collapse in alveoli which reduces or stops gas exchange. Illustration by the Cleveland Clinic.**

The physiological process of breathing is one of those variables that can be significantly impacted by atelectasis in the flight environment. Atelectasis is the collapse of the alveoli (air sacs) in your lungs which serve as the critical location for gas exchange between your blood and the air you breathe. There are two primary mechanisms leading to atelectasis that are important to understand in aviation: absorption atelectasis and acceleration atelectasis. Different gases are absorbed by the alveoli at varying rates with oxygen being relatively quickly absorbed compared to other gases. Breathing normal ambient air with 21% oxygen and 78% nitrogen, the body absorbs the needed oxygen but there is still plenty of nitrogen left behind to keep the alveoli expanded. As you increase the percentage of oxygen in the inspired air, the body keeps absorbing the oxygen at a faster rate than the nitrogen, meaning that over time there can be less nitrogen left to keep the alveoli expanded. When those alveoli collapse, the blood continues to flow through the vessels around the alveolar walls but the gas exchange process is not occurring (or not occurring as effectively as it normally does). This process is a common occurrence in

patients receiving high levels of oxygen during surgery as well. A related, often compounding, type of atelectasis is caused by the effects of Gs on the lungs. When the lungs are pulled down under G-force, the alveoli in the base of the lungs can collapse, producing a localized atelectasis. When you combine the two processes together, it can become additive and lead to further performance decline. In healthy aviators, you may not notice this change initially due to a large reserve of capacity that is able to overcome these temporary challenges.

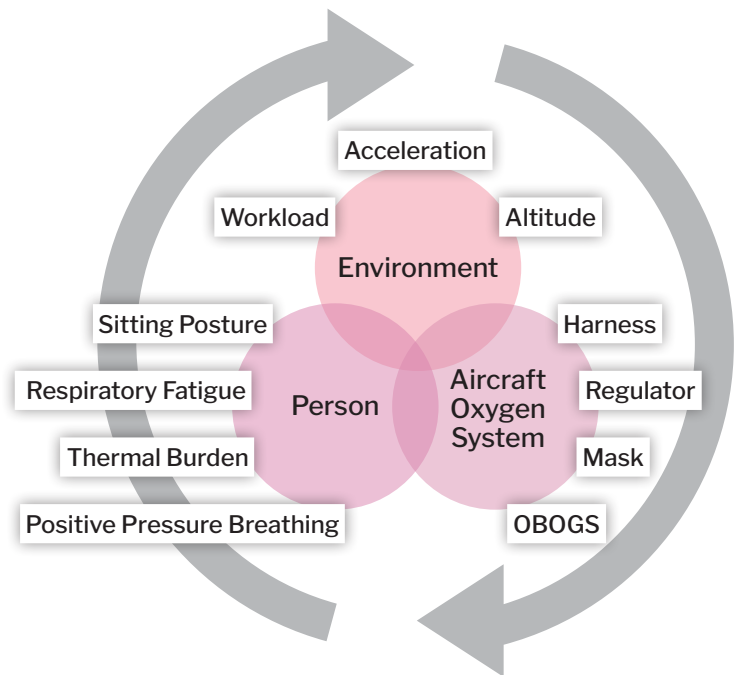
#### In-flight breathing dynamics.

Breathing dynamics in the flight environment are very different in sitting position, G-forces and other human factors. Acceleration atelectasis can be caused by as little as 3 G's and as few as two subsequent 5-G exposures which can reduce your lung capacity by 60%. Breathing high concentrations of oxygen further exacerbates this condition. Another issue in flight is lung compliance, which is the ability of your lungs to expand. A reduction in lung compliance increases your work of breathing and can change your breathing dynamics. Poor posture, an improperly fitted or incorrectly worn parachute harness and expansion of the abdominal bladder in your G-suit can all lead to a reduction in lung compliance and make it harder to fully expand your lungs. All these factors can increase the likelihood of developing atelectasis. Taking deep breaths is an important way to re-inflate collapsed alveoli in your lungs. Maintaining good posture and avoiding the “helo-hunch” will also help with improving lung compliance. Pay particular attention to the fit of your parachute harness as a low chest strap placement will reduce your ability to take deep breaths. Ensure your chest strap is at or slightly above nipple level. Your G-suit must also fit properly to reduce the potential adverse effects it can have on your diaphragm movement. Ensure proper abdominal bladder placement and that you have at least two fingers’ worth of room

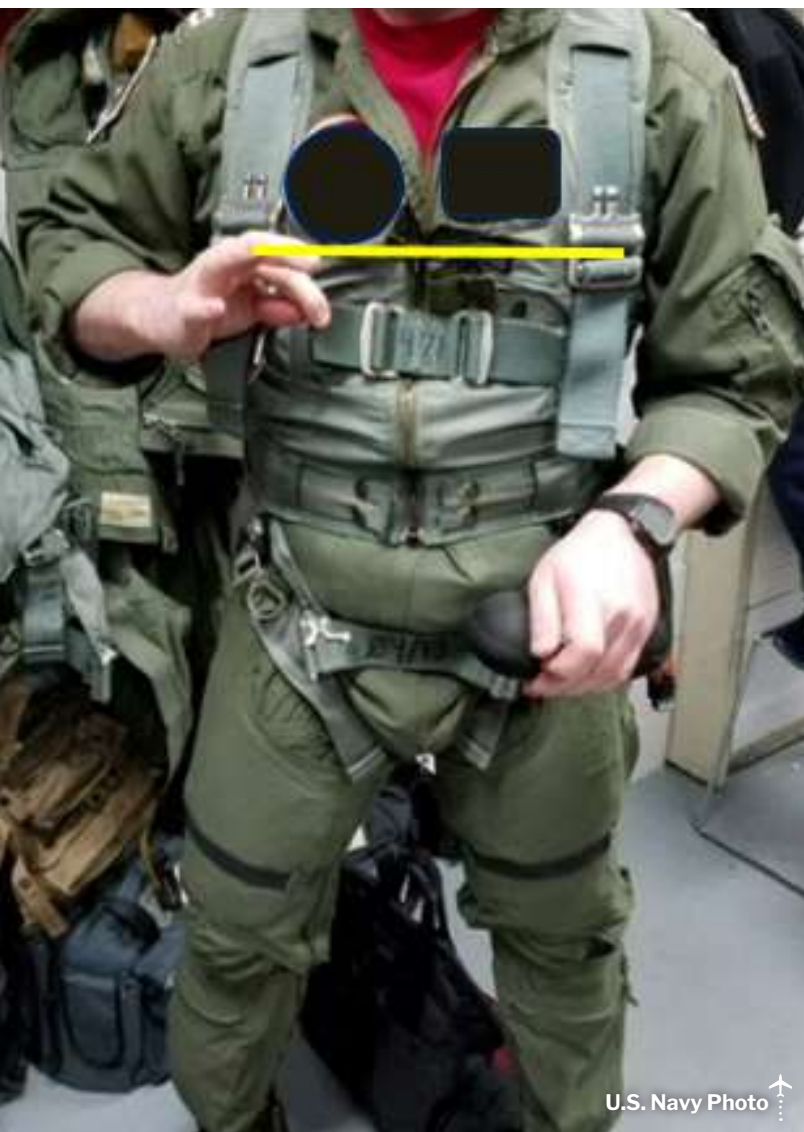
**The yellow line indicates proper chest strap position on the parachute harness.**

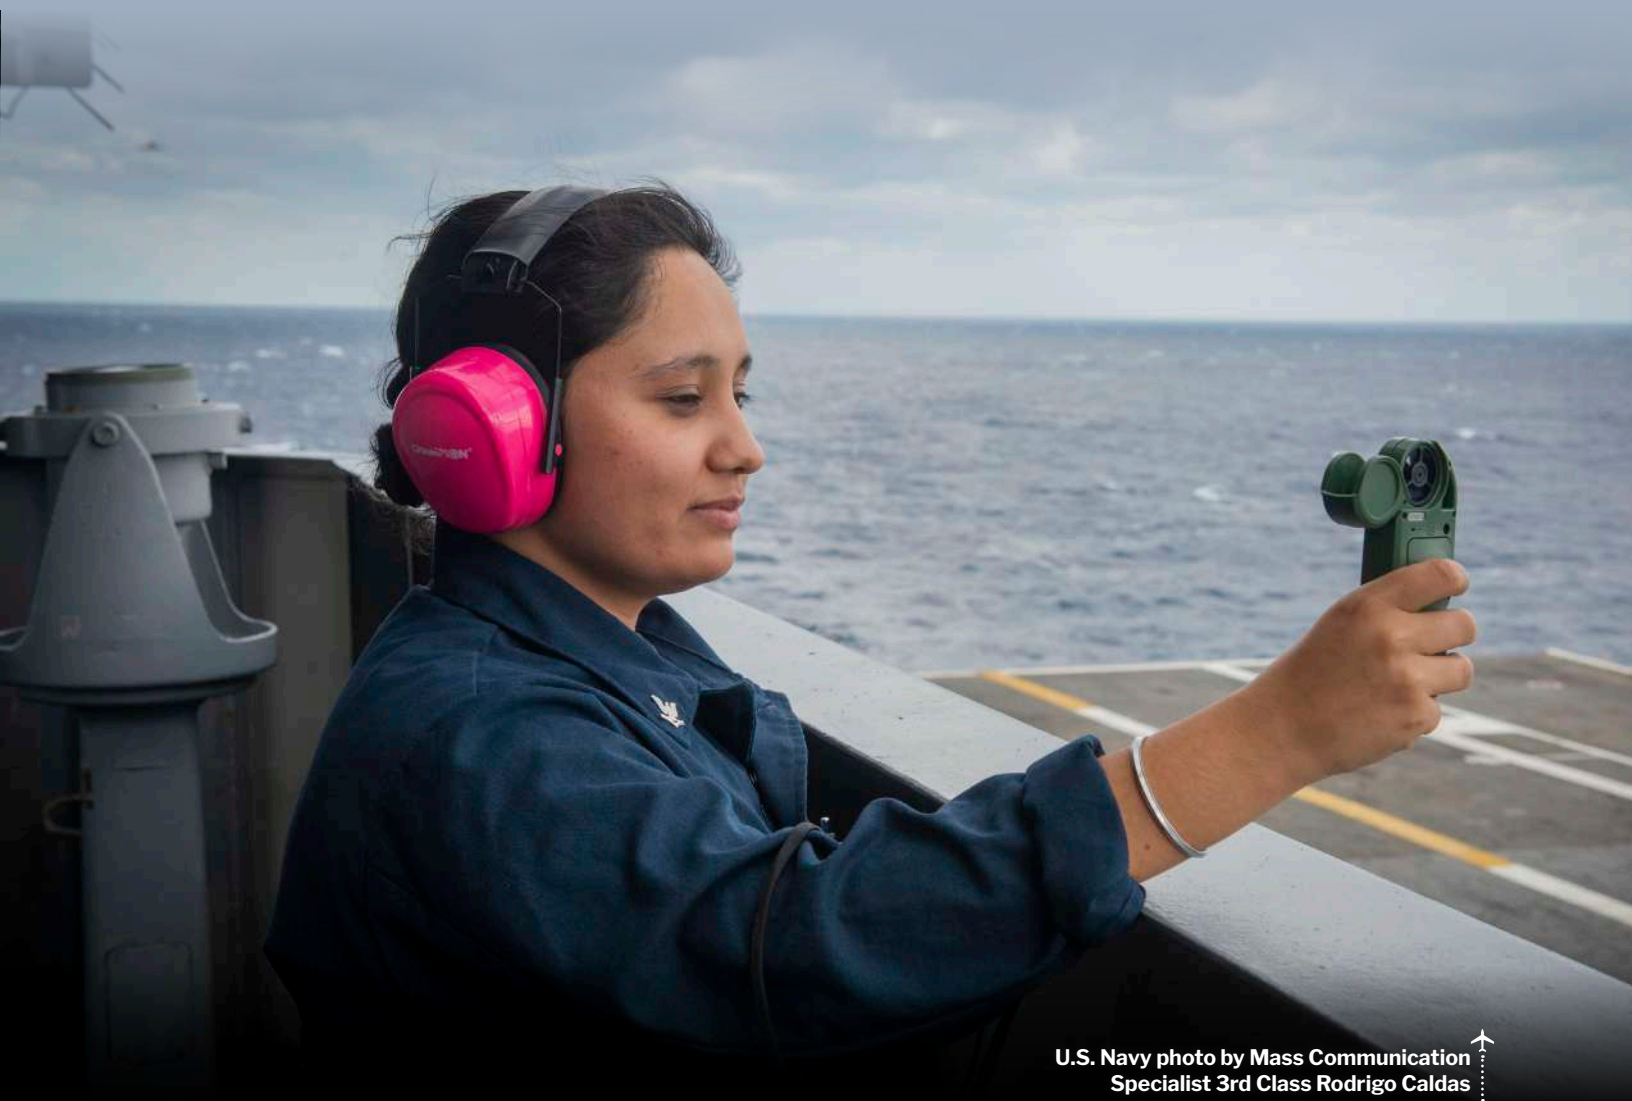
U.S. Navy photo by Mass Communication Specialist 3rd Class Rodrigo Caldas ↑

Aerographer's Mate 3rd Class Harpreet Jassal measures the temperature and wind speed aboard the Nimitz-class aircraft carrier USS Dwight D. Eisenhower (CVN 69).

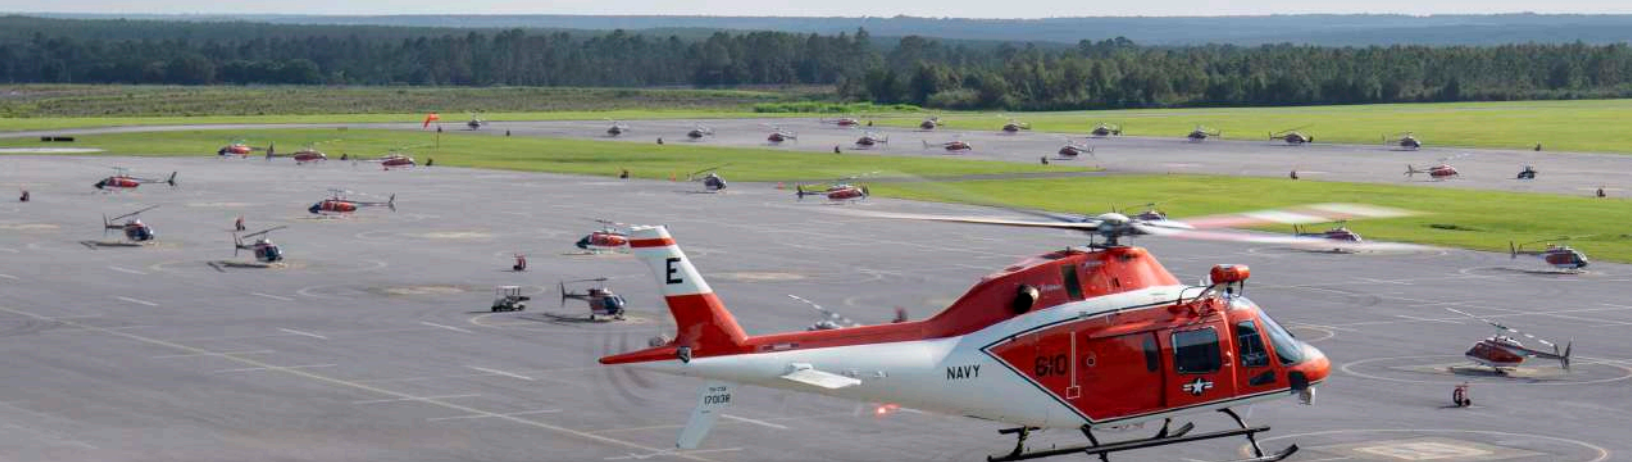
The TH-73A will be assigned to Training Air Wing 5 on base and will replace the TH-57B/C Sea Ranger as the undergraduate rotary and tilt-rotor helicopter trainer.
