THE NAVY AND MARINE CORPS AVIATION SAFETY MAGAZINE

# Approach

VOL. 68, NO. 1

Spring 2026

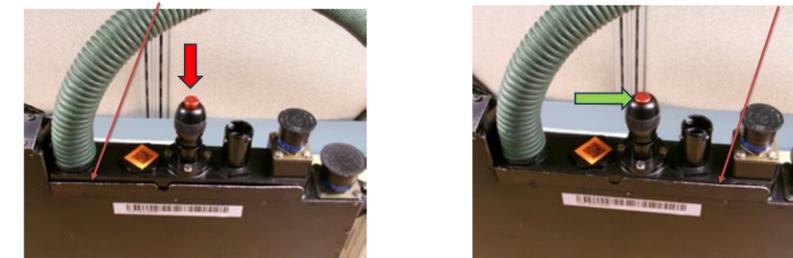
Disconnected – Improper seating, red button not clicked in. PIC not flush with SPA.

Connected – Properly seated, red button fully pressed in, audible 'click' heard. PIC flush with SPA.

Figure 4. Check the PIC connection if breathing becomes difficult. The red button should be fully pressed in.

A PIC disconnect is a condition potentially interrupting air flow from the OBOGS at the Seat Portion Assembly (SPA). The degree of separation between the PIC and SPA will determine whether or not airflow is completely interrupted. A PIC disconnect is associated with the following ICAWs: CABIN PRESS, OXYGEN CRITICAL, BOS LO, BOS ON, BOS OVERRIDE, OXY FLOW DEGD and PBA FAIL. These ICAWs in conjunction with

difficulty breathing should cue pilots to check their PIC connection (Figure 4).

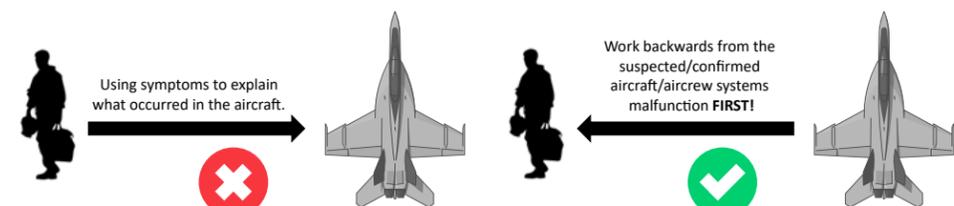
Figure 1. A proper problem diagnosis is to work from the suspected/confirmed aircraft/aircrew systems malfunction.

to the aircraft to try and determine why the aviator was having symptoms (Figure 1).

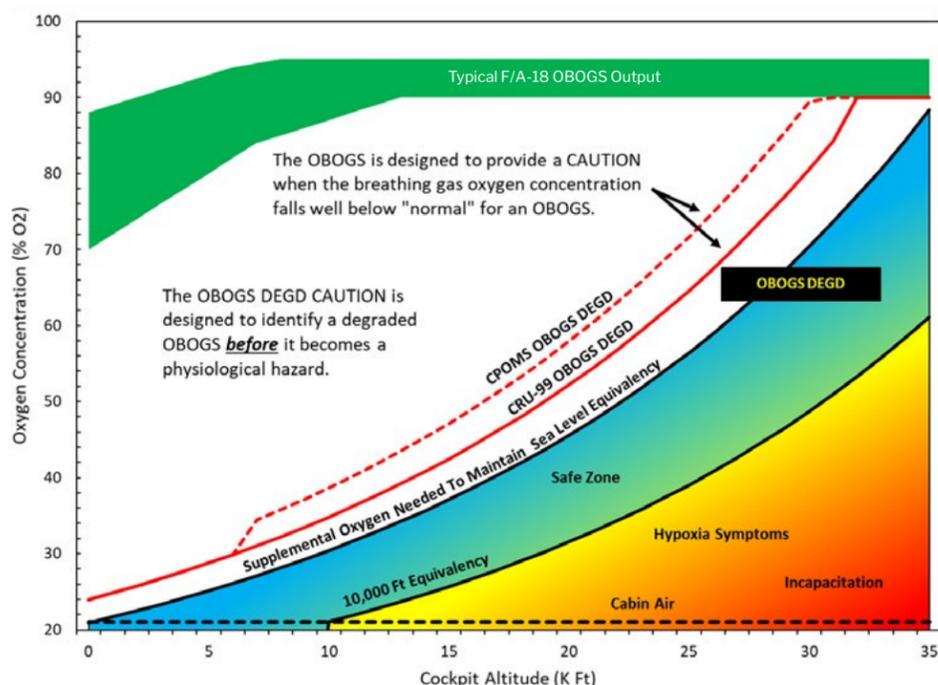
Figure 2. The OBOGS DEGD caution is a system fault detection caution, and not a physiological hazard indication.

Over the past seven years, the PEAT has investigated multiple physiological events that reported immediate symptoms following an OBOGS DEGD or degraded caution light. From a systems and physiological perspective, this is often a sympathetic nervous system response. The CRU-99 oxygen monitor sets the OBOGS DEGD threshold at a sea level equivalency of 182 mmHG partial pressure of oxygen (PPO2). This is equivalent to 24% oxygen, which is greater than the nominal 21% oxygen at sea level (Figure 2).

This means the OBOGS DEGD caution is set at an oxygen concentration greater than ambient sea level oxygen PPO2 but does not constitute an immediate physiological danger to aviators. Think of OBOGS DEGD as an early warning system for impending OBOGS failure. The plenum, located after the oxygen sensor at the OBOGS outlet, provides an additional void space within the oxygen system, temporarily mitigating or buffering decreases in oxygen concentration after an OBOGS DEGD caution.

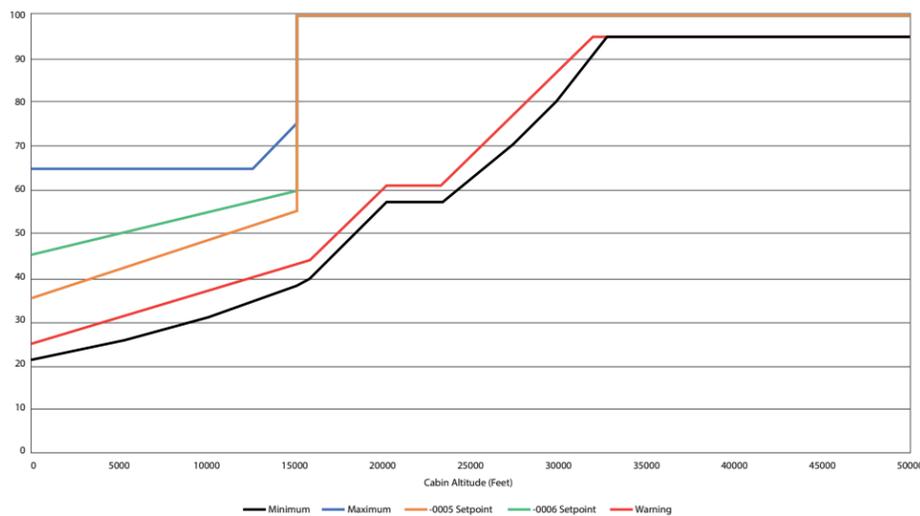
Figure 5. -0005 and -0006 OBOGS Oxygen Concentration Limits vs. Cabin Altitude.
